## Access Compliance Report Public Rights-of-Way (Curb Ramps)

Intersection ID: 14980	Main Street: DILWORTH_RD_EAST			Street:	EAST_BV	Location:	W		
ADA ID: 9DD99F0570B5	Ramp Ty	Ramp Type: PerpDiag			nitial Pass/Fail: Fail Overall Compliance: No				21.25
Codes/Mitigation Info/Possible Solution				Field Measurements/Component Compliance					
		Possible Solutions:		Compliance Description Da			a Compliance Description		Data
		Remove & Replace Curb Ramp W	Vith	N/A	Ramp Length (in)	102.0	No	Ramp Slope (%)	10.3
		Two New Directional Ramps or		No	Ramp Width (in)	47.0	Yes	Ramp XSlope (%)	1.3
a al a a		Equivalent. Restripe Crosswalk.		N/A	Flare Type LT	N/A	N/A	Flare Type RT	N/A
A A A				N/A	Flare Slope LT (%)	N/A	N/A	Flare Slope RT (%)	N/A
Brown Brown				N/A	Flare Traversable LT?	N/A	N/A	Flare Traversable RT?	N/A
A A A A A A A A A A A A A A A A A A A	or the second states			N/A	Landing Length (in)	N/A	N/A	DWS Provided?	N/A
	S I	Surveyor Notes:		N/A	Landing Width (in)	N/A	N/A	DWS Contrast?	N/A

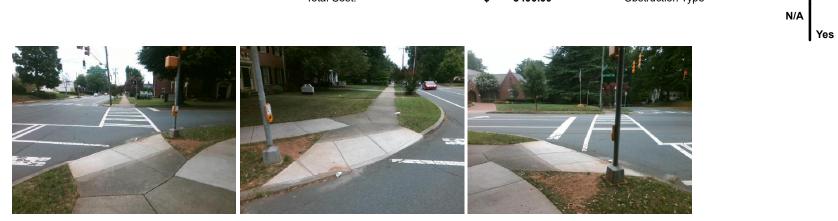
E.	A CAR	N/A		N/A	Landing Slope (%)	N/A	N/A	DWS Length (in)	N/A
PROW/ADA: Not Found, R304.5.1, R304.2.2				N/A	Landing X Slope (%)	N/A	N/A	DWS Full Width?	N/A
				N/A	Landing Curb? (Y/N)	N/A	N/A	DWS Offset (in)	N/A
				N/A	Shared Landing?	N/A		( )	
				N/A	Gutter Ponding?	N/A	N/A	Gutter Slope (%)	N/A
				N/A	Gutter Lip Ht (in)	N/A		Gutter X Slope (%)	N/A
				N/A	Painted X Walk1?	Yes	N/A	Painted X Walk2?	Yes
					X Walk 1 Direction	To SE		X Walk 2 Direction	To NE
a the second				N/A	X Walk 1 Width (in)	112.0	N/A	X Walk 2 Width (in)	112.0
Street 1 Name	DILWORTH RD EAST	-			X Walk 1 Slope (%)	2.6		X Walk 2 Slope (%)	6.1
Stop Condition-Street 2	Signal				X Walk 1 X Slope (%)	6.6		X Walk 2 X Slope (%)	3.2
Street 2 Name	EAST BV			N/A	Ramp inside XWalk1?	Yes	N/A	Ramp inside XWalk2?	No
Stop Condition-Street 1	Signal				Road Slope (%)	3.1	N/A	Clear Space?	N/A

0.9.141				Road X Slope (%)	7.5	N/A	Clear Space to XWalk (in)	N/A
				N/A	Any Obstructions?	N/A	N/A	Storm Grate/Utility Hazard?	N/A
		Total Cost: \$ 3	400.00		Obstruction Type			Storm Grate/Utility Type	
		•••••				N/A			N/A
