Access Compliance Report

Public Rights-of-Way

(Curb Ramps)

Intersection ID: 42867	Main Street: IDLEWILD_RD_NORTH	Cross Street: ROSEHALL_DR	Location: SE
ADA ID: 9DDDB51454E1D	Ramp Type: PerpDiag	Initial Pass/Fail: Fail	Overall Compliance: No
Severity Score: 12.5			
Codes/Mitigation Info/Possible Solution		Field Measurements/Component Compliance

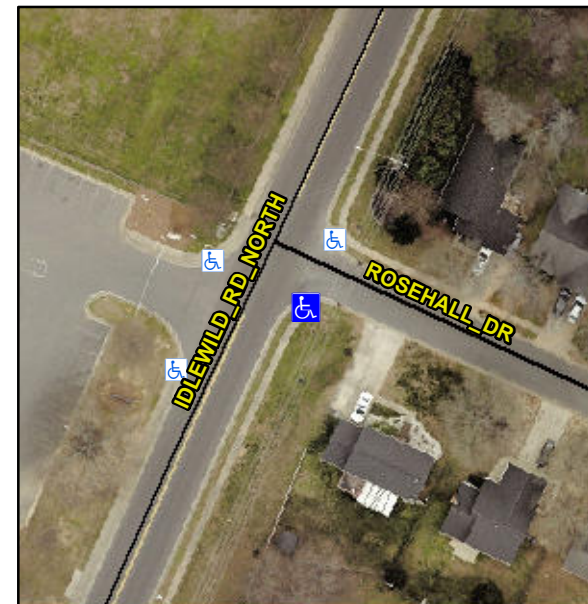
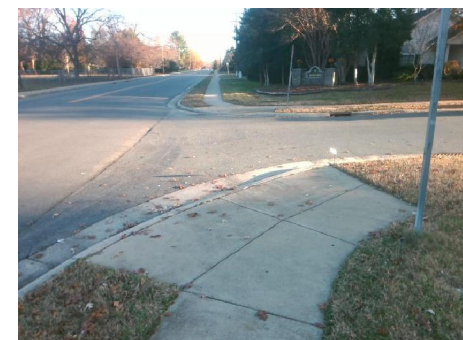
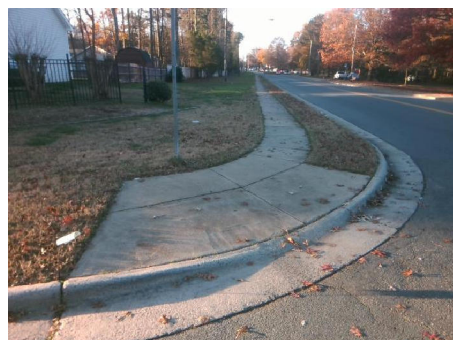
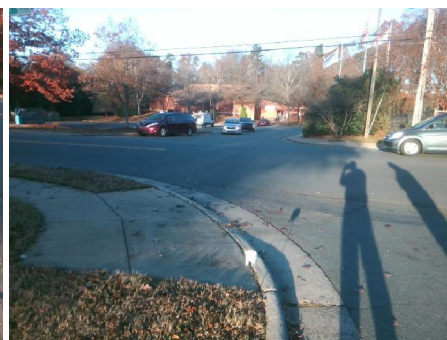
PROW/ADA:

Not Found, R304.2.2

Compliance	Description	Data	Compliance	Description	Data
N/A	Ramp Length (in)	54.0	No	Ramp Slope (%)	9.2
Yes	Ramp Width (in)	48.0	Yes	Ramp XSlope (%)	1.1
N/A	Flare Type LT	N/A	N/A	Flare Type RT	N/A
N/A	Flare Slope LT (%)	N/A	N/A	Flare Slope RT (%)	N/A
N/A	Flare Traversable LT?	N/A	N/A	Flare Traversable RT?	N/A
N/A	Landing Length (in)	N/A	N/A	DWS Provided?	N/A
N/A	Landing Width (in)	N/A	N/A	DWS Contrast?	N/A
N/A	Landing Slope (%)	N/A	N/A	DWS Length (in)	N/A
N/A	Landing X Slope (%)	N/A	N/A	DWS Full Width?	N/A
N/A	Landing Curb? (Y/N)	N/A	N/A	DWS Offset (in)	N/A
N/A	Shared Landing?	N/A			
N/A	Gutter Ponding?	N/A	N/A	Gutter Slope (%)	N/A
N/A	Gutter Lip Ht (in)	N/A	N/A	Gutter X Slope (%)	N/A
N/A	Painted X Walk1?	No	N/A	Painted X Walk2?	No
	X Walk 1 Direction	To NE		X Walk 2 Direction	To NW
N/A	X Walk 1 Width (in)	N/A	N/A	X Walk 2 Width (in)	N/A
	X Walk 1 Slope (%)	0.2		X Walk 2 Slope (%)	1.2
	X Walk 1 X Slope (%)	0.9		X Walk 2 X Slope (%)	1.1

N/A	Ramp inside XWalk1?	N/A	N/A	Ramp inside XWalk2?	N/A
	Road Slope (%)	0.2	N/A	Clear Space?	N/A
	Road X Slope (%)	0.4	N/A	Clear Space to XWalk (in)	N/A
N/A	Any Obstructions?	N/A	N/A	Storm Grate/Utility Hazard?	N/A
	Obstruction Type			Storm Grate/Utility Type	
		N/A			N/A
		Yes		Surface Condition? (G/P)	Good

Possible Solutions:

Remove & Replace Curb Ramp With Two New Directional Ramps or Equivalent.
