# Access Compliance Report

## Public Rights-of-Way

### (Curb Ramps)

Intersection ID: 10611	Main Street: CLAY_AV	Cross Street: TUCKASEEGEE_RD	Location: W
ADA ID: 9DDF7855CD6A	Ramp Type: Directional1	Initial Pass/Fail: Fail	Overall Compliance: No
			Severity Score: 13.75

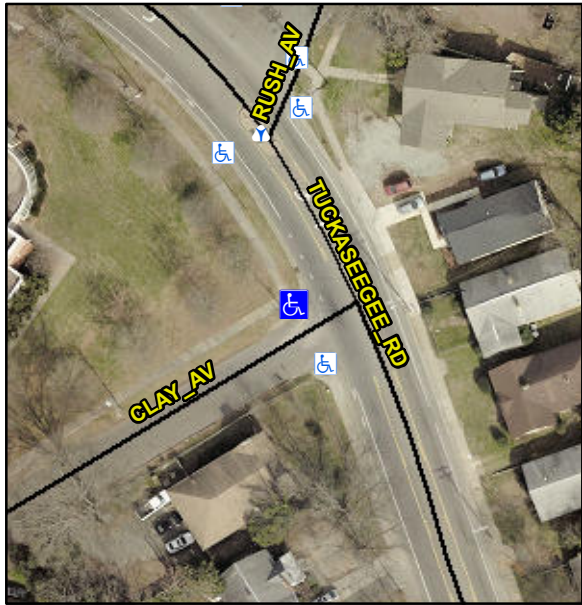
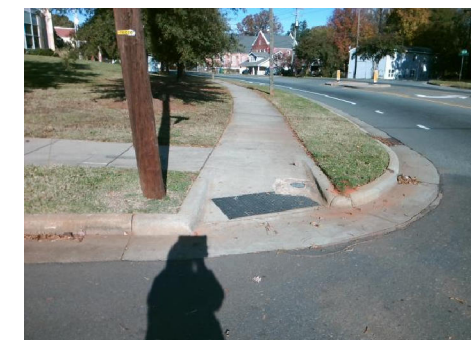
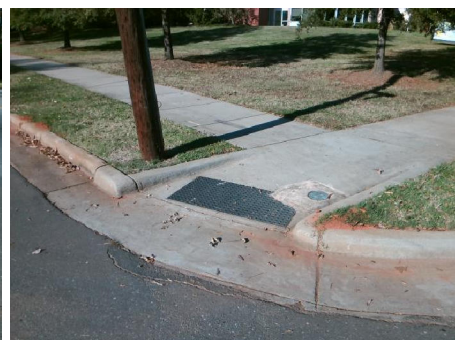
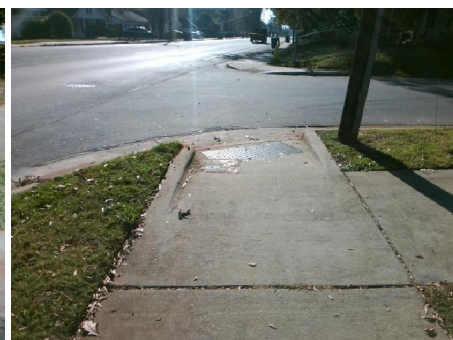
Possible Solutions:		Compliance	Description	Data	Compliance	Description	Data
	Remove & Replace Entire Ramp.		N/A	Ramp Length (in)	63.0	N/A	Grade Break?	N/A
			Yes	Ramp Width (in)	58.0	N/A	Grade Break Slope (%)	0.0
			No	Ramp Slope (%)	9.1	N/A	Grade Break XSlope (%)	0.0
			No	Ramp XSlope (%)	3.9			
			N/A	Flare Type LT	N/A	N/A	Flare Type RT	N/A
			N/A	Flare Slope LT (%)	N/A	N/A	Flare Slope RT (%)	0.0
			N/A	Flare Traversable LT?	N/A	N/A	Flare Traversable RT?	N/A
			N/A	Landing Length (in)	0.0	N/A	DWS Provided?	N/A
			N/A	Landing Width (in)	0.0	N/A	DWS Contrast?	N/A
Surveyor Notes:			N/A	Landing Slope (%)	0.0	N/A	DWS Length (in)	N/A
N/A			N/A	Landing X Slope (%)	0.0	N/A	DWS Full Width?	N/A
PROW/ADA:			N/A	Landing Curb? (Y/N)	N/A	N/A	DWS Offset LT (in)	N/A
R304.2.2, R304.5.3			N/A	Shared Landing?	N/A	N/A	DWS Offset RT (in)	N/A

N/A	Gutter Ponding?	0.0	N/A	Gutter Slope (%)	N/A
			N/A	Gutter Lip Ht (in)	0.0	N/A	Gutter X Slope (%)	N/A
			N/A	Painted X Walk1?	No		Road Slope (%)	1.0
				X Walk 1 Direction	To SE		Road X Slope (%)	1.1
				X Walk 1 Width (in)	N/A		Clear Space?	N/A
				X Walk 1 Slope (%)	1.0	N/A	Clear Space to XWalk (in)	N/A
				X Walk 1 X Slope (%)	1.1	N/A	Storm Grate/Utility Hazard?	N/A
			N/A	Ramp inside XWalk1?	N/A		Storm Grate/Utility Type	
			N/A	Any Obstructions?	N/A			N/A
				Obstruction Type		Yes	Surface Condition? (G/P)	Good
					N/A	N/A	Curb Slope (%)	5.8
Street 1 Name		CLAY AV						
Stop Condition-Street 1		StopSign						
Street 2 Name		N/A						
Stop Condition-Street 2		N/A						
Total Cost:		\$ 1600.00
