## Access Compliance Report Public Rights-of-Way (Curb Ramps)

Intersection ID: 2802	n ID: 2802 Main Street: DOWNFIELD_WOOD_DR				Street:	HIGHLAND_CREEK_	Location:	SE		
ADA ID: 9DE22B461AB6	36 Ramp Type: Perp				tial Pass/Fail: Pass Overall Compliance: No				o Severity Score:	7.75
Codes/Mitigation Info/Possible Solution					Field Measurements/Component Compliance					
110-1074		Possible Solutions:			Compliance Description		Data Compliance Description		Data	
and and and	1 / J	Remove & Replace Entire Remove & Replace Gutter	Entire Ramp		N/A	Ramp Length (in)	141.0	Yes	Ramp Slope (%)	6.9

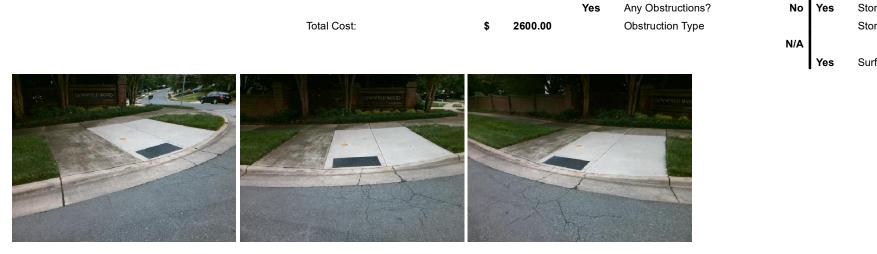
- 200			•		Yes	Ramp Width (in)	60.0	Yes	Ramp XSlope (%)	3.4
					N/A	Flare Type LT	Sloped	N/A	Flare Type RT	N/A
the second se	TER PI				N/A	Flare Slope LT (%)	1.2	Yes	Flare Slope RT (%)	8.5
A CONTRACTOR				N/A	Flare Traversable LT?	Yes	N/A	Flare Traversable RT?	Yes	
MEALAN	1000				Yes	Landing Length (in)	51.0	Yes	DWS Provided?	Yes

- Million Pro-	100 P 2 4	Surveyor Notes:			Yes	Landing Width (in)	55.5	Yes	DWS Contrast?	Yes
		N/A			No	Landing Slope (%)	2.6	Yes	DWS Length (in)	24.0
					No	Landing X Slope (%)	5.4	No	DWS Full Width?	No
					N/A	Landing Curb? (Y/N)	No	No	DWS Offset (in)	3.5
	10 000				N/A	Shared Landing?	Yes			
No.		PROW/ADA:			Yes	Gutter Ponding?	No	No	Gutter Slope (%)	7.7
	2-1-14	R304.2.2-Perp, R304	.3.2-Para,		Yes	Gutter Lip Ht (in)	0.0	Yes	Gutter X Slope (%)	2.8
		R304.5.3, R305.1.4, I		.5.4	N/A	Painted X Walk1?	No	N/A	Painted X Walk2?	N/A
					X Walk 1 Direction	To N		X Walk 2 Direction	N/A	
					N/A	X Walk 1 Width (in)	N/A	N/A	X Walk 2 Width (in)	N/A
Street 1 Name	HIGHLAND CREEK PY					X Walk 1 Slope (%)	6.4		X Walk 2 Slope (%)	N/A
Stop Condition-Street 2	None					X Walk 1 X Slope (%)	4.3		X Walk 2 X Slope (%)	N/A
Street 2 Name	N/A				N/A	Ramp inside XWalk1?	N/A	N/A	Ramp inside XWalk2?	N/A
Stop Condition-Street 1	N/A					Road Slope (%)	N/A	N/A	Clear Space?	Yes

Road X Slope (%)	N/A	N/A	Clear Space to XWalk (in)	N/A
					Yes	Any Obstructions?	No	Yes	Storm Grate/Utility Hazard?	No
		Total Cost:	\$ 2	2600.00		Obstruction Type			Storm Grate/Utility Type	
							N/A			N/A
