Access Compliance Report

Public Rights-of-Way

(Curb Ramps)

Intersection ID: 3877	Main Street: DELLFIELD_WY	Cross Street: ROBIN_LN	Location: SW
ADA ID: 9DE883FB8217	Ramp Type: Perp	Initial Pass/Fail: Fail	Overall Compliance: No
Severity Score: 46.25			
Codes/Mitigation Info/Possible Solution		Field Measurements/Component Compliance

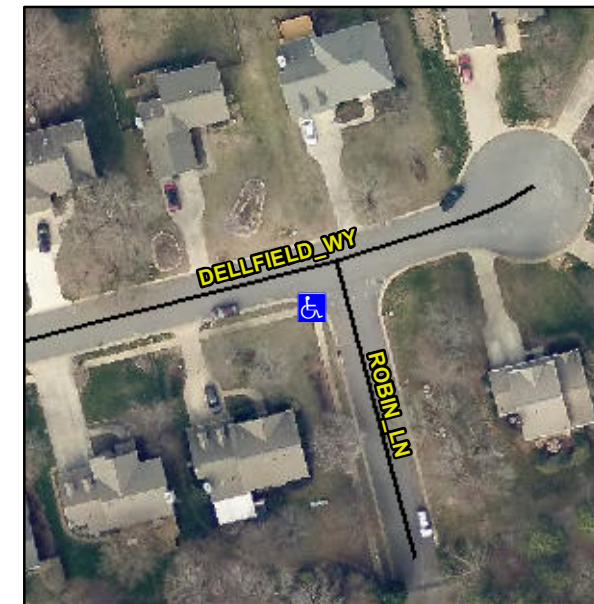
Not Found, R304.5.1, R304.2.2, R304.5.3

Compliance	Description	Data	Compliance	Description	Data
N/A	Ramp Length (in)	57.5	No	Ramp Slope (%)	10.7
No	Ramp Width (in)	37.0	No	Ramp XSlope (%)	10.2
N/A	Flare Type LT	N/A	N/A	Flare Type RT	N/A
N/A	Flare Slope LT (%)	N/A	N/A	Flare Slope RT (%)	N/A
N/A	Flare Traversable LT?	N/A	N/A	Flare Traversable RT?	N/A
N/A	Landing Length (in)	N/A	N/A	DWS Provided?	N/A
N/A	Landing Width (in)	N/A	N/A	DWS Contrast?	N/A
N/A	Landing Slope (%)	N/A	N/A	DWS Length (in)	N/A
N/A	Landing X Slope (%)	N/A	N/A	DWS Full Width?	N/A
N/A	Landing Curb? (Y/N)	N/A	N/A	DWS Offset (in)	N/A
N/A	Shared Landing?	N/A			
N/A	Gutter Ponding?	N/A	N/A	Gutter Slope (%)	N/A
N/A	Gutter Lip Ht (in)	N/A	N/A	Gutter X Slope (%)	N/A
N/A	Painted X Walk1?	No	N/A	Painted X Walk2?	N/A
	X Walk 1 Direction	To E		X Walk 2 Direction	N/A
N/A	X Walk 1 Width (in)	N/A	N/A	X Walk 2 Width (in)	N/A
	X Walk 1 Slope (%)	6.8		X Walk 2 Slope (%)	N/A
	X Walk 1 X Slope (%)	6.9		X Walk 2 X Slope (%)	N/A

Possible Solutions:

Remove & Replace Entire Ramp.

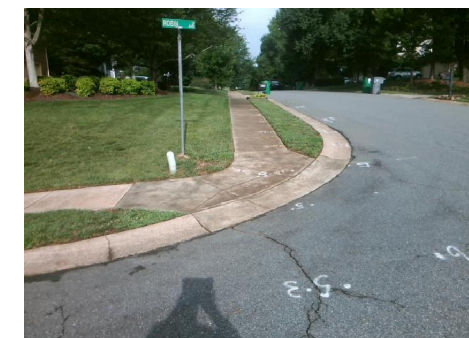
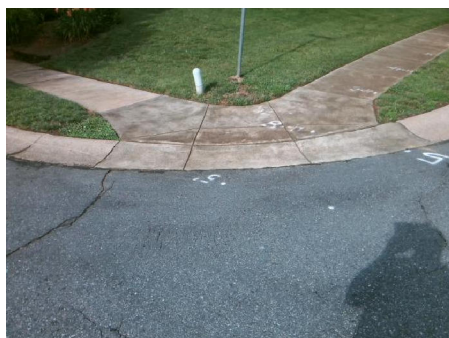
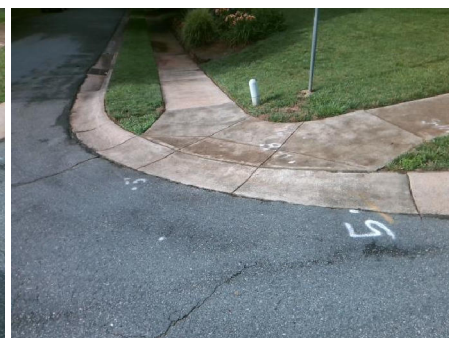
N/A	Ramp inside XWalk1?	N/A	N/A	Ramp inside XWalk2?	N/A
	Road Slope (%)	N/A	N/A	Clear Space?	N/A
	Road X Slope (%)	N/A	N/A	Clear Space to XWalk (in)	N/A
N/A	Any Obstructions?	N/A	N/A	Storm Grate/Utility Hazard?	N/A
	Obstruction Type			Storm Grate/Utility Type	
		N/A			N/A
			Yes	Surface Condition? (G/P)	Good
