# Access Compliance Report

## Public Rights-of-Way

### (Curb Ramps)

Intersection ID: N/A	Main Street: SAWMILL_TRACE_DR	Cross Street: WHITE_MOON_CT	Location: N
ADA ID: 9DF9E892C3E4	Ramp Type: Combination1Diag	Initial Pass/Fail: Fail	Overall Compliance: No
			Severity Score: 0

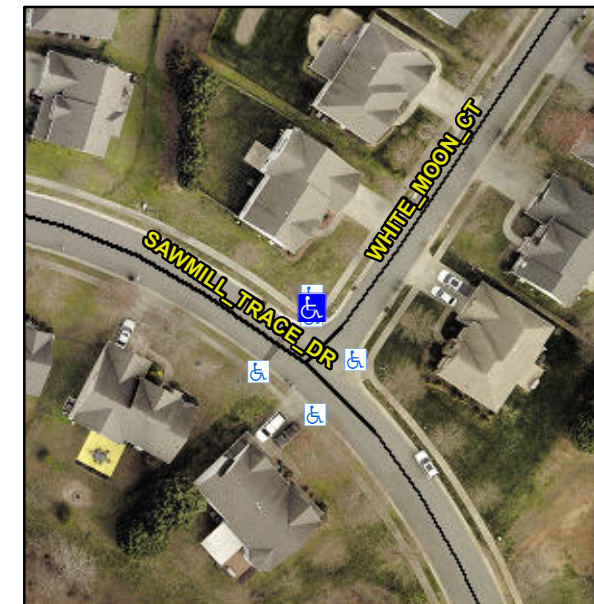
**Not Found, R304.5.1, R304.5.1, R304.2.2, R304.5.3, R304.3.2**

Compliance	Description	Data	Compliance	Description	Data
N/A	Ramp Length LT (in)	37.0	N/A	Ramp Length RT (in)	26.5
No	Ramp Width LT (in)	46.5	No	Ramp Width RT (in)	46.5
No	Ramp Slope LT (%)	9.0	No	Ramp Slope RT (%)	9.2
No	Ramp XSlope LT (%)	3.0	No	Ramp XSlope RT (%)	3.1
N/A	Ramp Length (in)	45.5	No	Ramp Slope (%)	9.0
No	Ramp Width (in)	39.0	No	Ramp XSlope (%)	5.8
N/A	Flare Type LT	N/A	N/A	Flare Type RT	N/A
N/A	Flare Slope LT (%)	N/A	N/A	Flare Slope RT (%)	N/A
N/A	Flare Traversable LT?	N/A	N/A	Flare Traversable RT?	N/A
N/A	Landing Length (in)	N/A	N/A	DWS Provided?	N/A
N/A	Landing Width (in)	N/A	N/A	DWS Contrast?	N/A
N/A	Landing Slope (%)	N/A	N/A	DWS Length (in)	N/A
N/A	Landing X Slope (%)	N/A	N/A	DWS Full Width?	N/A
N/A	Landing Curb? (Y/N)	N/A	N/A	DWS Offset (in)	N/A
N/A	Shared Landing?	N/A			
N/A	Gutter Ponding?	N/A	N/A	Gutter Slope (%)	N/A
N/A	Gutter Lip Ht (in)	N/A	N/A	Gutter X Slope (%)	N/A
N/A	Painted X Walk1?	No	N/A	Painted X Walk2?	No

X Walk 1 Direction	To SW		X Walk 2 Direction	To SE
	X Walk 1 Width (in)	N/A		X Walk 2 Width (in)	N/A
	X Walk 1 Slope (%)	1.0		X Walk 2 Slope (%)	4.9
	X Walk 1 X Slope (%)	4.9		X Walk 2 X Slope (%)	3.1
N/A	Ramp inside XWalk1?	N/A	N/A	Ramp inside XWalk2?	N/A
	Road Slope (%)	5.9		Clear Space?	N/A
	Road X Slope (%)	1.5	N/A	Clear Space to XWalk (in)	N/A
			N/A	Any Obstruction?	N/A
				Obstruction Type	N/A
			N/A	Storm Grate/Utility Hazard?	N/A
				Storm Grate/Utility Type	N/A
					N/A
Yes	Surface Condition? (G/P)	Good			
	Curb Slope (%)	13.9

**Remove & Replace Curb Ramp With Two New Directional Ramps or Equivalent.**

Total Cost: \$ 3200.00
