Access Compliance Report

Public Rights-of-Way

(Curb Ramps)

Intersection ID: 12413	Main Street: N_BREVARD_ST	Cross Street: E_6TH_ST	Location: W
ADA ID: 9E02DEF7A610	Ramp Type: Perp	Initial Pass/Fail: Fail	Overall Compliance: No
		Severity Score: 12.5

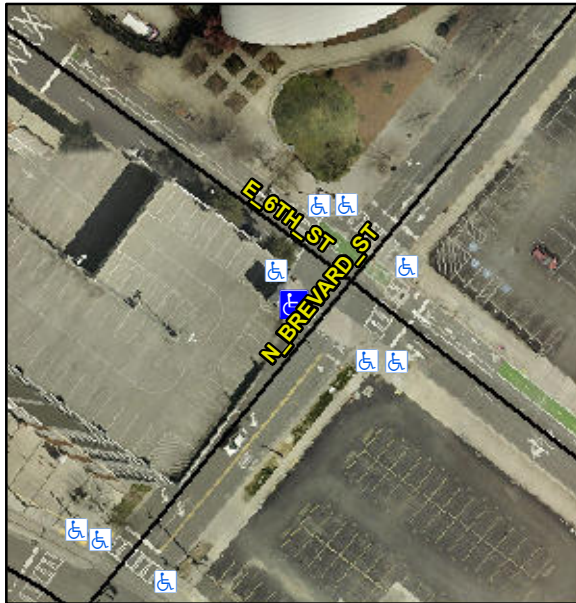
Not Found, R304.2.2

Compliance	Description	Data	Compliance	Description	Data
N/A	Ramp Length (in)	72.0	No	Ramp Slope (%)	8.7
Yes	Ramp Width (in)	48.0	Yes	Ramp XSlope (%)	1.7
N/A	Flare Type LT	N/A	N/A	Flare Type RT	N/A
N/A	Flare Slope LT (%)	N/A	N/A	Flare Slope RT (%)	N/A
N/A	Flare Traversable LT?	N/A	N/A	Flare Traversable RT?	N/A
N/A	Landing Length (in)	N/A	N/A	DWS Provided?	N/A
N/A	Landing Width (in)	N/A	N/A	DWS Contrast?	N/A
N/A	Landing Slope (%)	N/A	N/A	DWS Length (in)	N/A
N/A	Landing X Slope (%)	N/A	N/A	DWS Full Width?	N/A
N/A	Landing Curb? (Y/N)	N/A	N/A	DWS Offset (in)	N/A
N/A	Shared Landing?	N/A			
N/A	Gutter Ponding?	N/A	N/A	Gutter Slope (%)	N/A
N/A	Gutter Lip Ht (in)	N/A	N/A	Gutter X Slope (%)	N/A
N/A	Painted X Walk1?	Yes	N/A	Painted X Walk2?	N/A
	X Walk 1 Direction	To SE		X Walk 2 Direction	N/A
N/A	X Walk 1 Width (in)	112.0	N/A	X Walk 2 Width (in)	N/A
	X Walk 1 Slope (%)	0.9		X Walk 2 Slope (%)	N/A
	X Walk 1 X Slope (%)	2.1		X Walk 2 X Slope (%)	N/A

N/A	Ramp inside XWalk1?	Yes	N/A	Ramp inside XWalk2?	N/A
	Road Slope (%)	N/A	N/A	Clear Space?	N/A
	Road X Slope (%)	N/A	N/A	Clear Space to XWalk (in)	N/A
N/A	Any Obstructions?	N/A	N/A	Storm Grate/Utility Hazard?	N/A
	Obstruction Type			Storm Grate/Utility Type	
		N/A			N/A
			Yes	Surface Condition? (G/P)	Good

Remove & Replace Entire Ramp.
