# Access Compliance Report

## Public Rights-of-Way

| Intersection ID: 43114 | Main Street: HAMORTON_PL | Cross Street: THE_PLAZA | Location: NE |
| ADA ID: 9E1BE23812E8 | Ramp Type: Directional1 | Initial Pass/Fail: Pass | Overall Compliance: No |

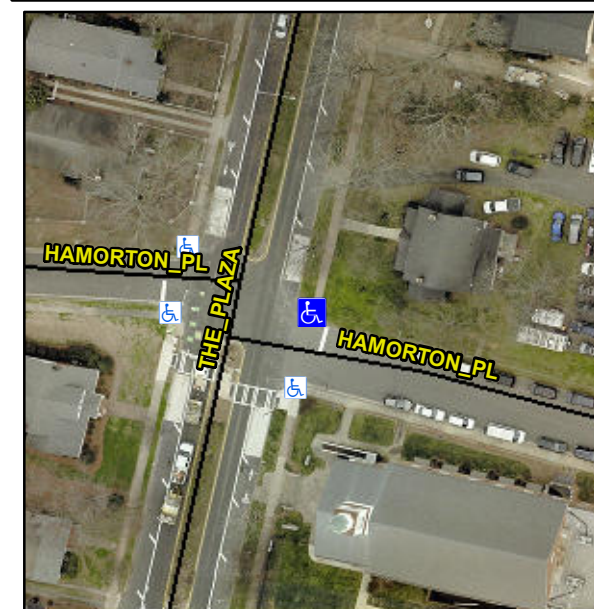
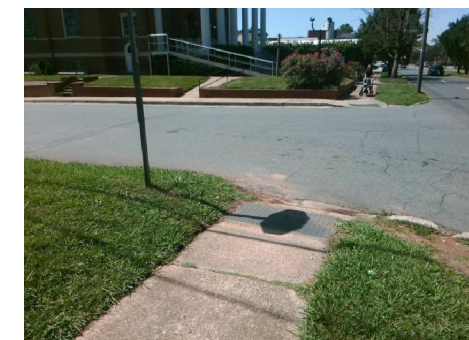
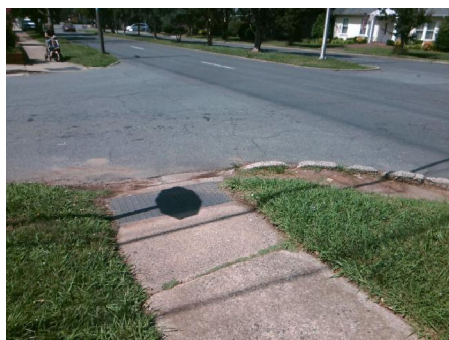
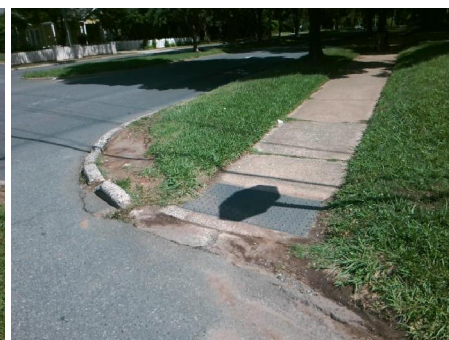
**NO CURB**

**R304.2.2-Perp, R304.3.2-Para,  
R304.5.3, R305.2, R302.7**

| Compliance | Description | Data | Compliance | Description | Data |
|---|---|---|---|---|---|
| Yes | Ramp Width (in) | 51.0 | No | Grade Break Slope (%) | 6.0 |
| No | Landing Slope (%) | 7.0 | Yes | DWS Length (in) | 24.0 |
| No | Gutter Ponding? | Yes | Yes | Gutter Slope (%) | 4.5 |
| Yes | Gutter Lip Ht (in) | 0.0 | No | Gutter X Slope (%) | 2.1 |

**Remove & Replace Entire Ramp.**  
**Remove & Replace Gutter.**
