Access Compliance Report

Public Rights-of-Way

(Curb Ramps)

Intersection ID: 48433	Main Street: WHITHORN_WY	Cross Street: SEAMILL_RD	Location: SE
ADA ID: 9E1D23CE03FC	Ramp Type: PerpDiag	Initial Pass/Fail: Fail	Overall Compliance: No
Codes/Mitigation Info/Possible Solution		Field Measurements/Component Compliance	
Severity Score: 13.75

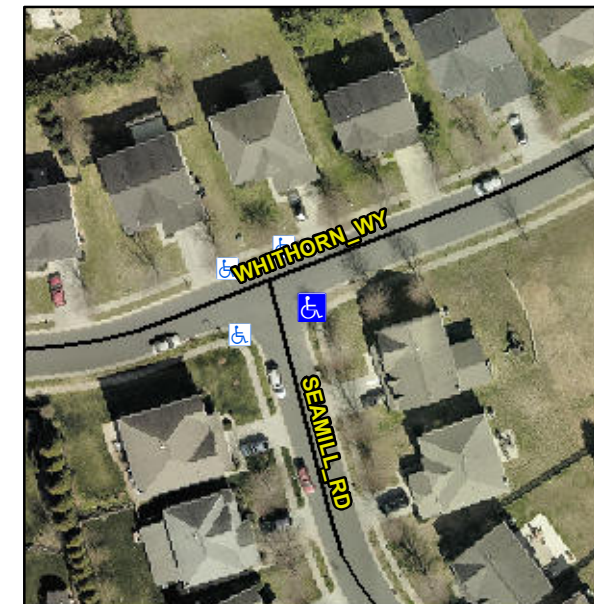
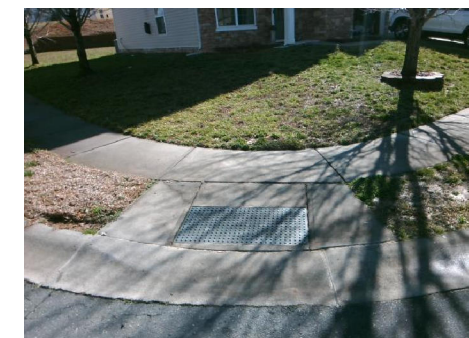
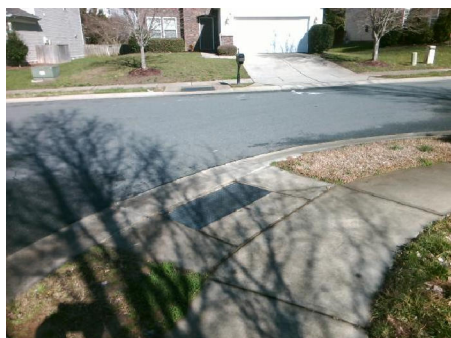
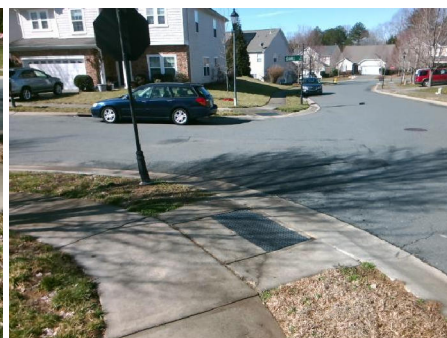
R304.2.2, R304.5.3

Compliance	Description	Data	Compliance	Description	Data
N/A	Ramp Length (in)	49.0	No	Ramp Slope (%)	11.1
Yes	Ramp Width (in)	48.0	No	Ramp XSlope (%)	4.9
N/A	Flare Type LT	N/A	N/A	Flare Type RT	N/A
N/A	Flare Slope LT (%)	N/A	N/A	Flare Slope RT (%)	N/A
N/A	Flare Traversable LT?	N/A	N/A	Flare Traversable RT?	N/A
N/A	Landing Length (in)	N/A	N/A	DWS Provided?	N/A
N/A	Landing Width (in)	N/A	N/A	DWS Contrast?	N/A
N/A	Landing Slope (%)	N/A	N/A	DWS Length (in)	N/A
N/A	Landing X Slope (%)	N/A	N/A	DWS Full Width?	N/A
N/A	Landing Curb? (Y/N)	N/A	N/A	DWS Offset (in)	N/A
N/A	Shared Landing?	N/A			
N/A	Gutter Ponding?	N/A	N/A	Gutter Slope (%)	N/A
N/A	Gutter Lip Ht (in)	N/A	N/A	Gutter X Slope (%)	N/A
N/A	Painted X Walk1?	No	N/A	Painted X Walk2?	No
	X Walk 1 Direction	To N		X Walk 2 Direction	To W
N/A	X Walk 1 Width (in)	N/A	N/A	X Walk 2 Width (in)	N/A
	X Walk 1 Slope (%)	2.3		X Walk 2 Slope (%)	0.2
	X Walk 1 X Slope (%)	2.8		X Walk 2 X Slope (%)	1.1

N/A	Ramp inside XWalk1?	N/A	N/A	Ramp inside XWalk2?	N/A
	Road Slope (%)	1.6	N/A	Clear Space?	N/A
	Road X Slope (%)	3.0	N/A	Clear Space to XWalk (in)	N/A
N/A	Any Obstructions?	N/A	N/A	Storm Grate/Utility Hazard?	N/A
	Obstruction Type			Storm Grate/Utility Type	
		N/A			N/A
		Yes		Surface Condition? (G/P)	Good

Remove & Replace Curb Ramp With Two New Directional Ramps or Equivalent.
