Access Compliance Report Public Rights-of-Way (Curb Ramps)

Intersection ID: 50730 Main Street: BANTEER_RD Cross Street: ALDERGROVE_RD Location: SE ADA ID: 9E2C05BE51DF **Overall Compliance: No** Ramp Type: PerpDiag Initial Pass/Fail: Fail **Severity Score:** 25

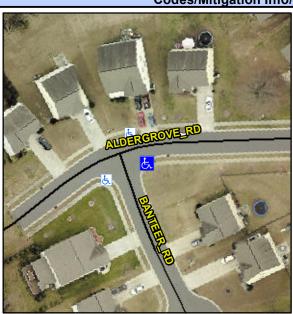
Field Measurements/Component Compliance							
Compliance Description		Data	Comp	liance Description	Data		
N/A	Ramp Length (in)	46.0	Yes	Ramp Slope (%)	8.0		
Yes	Ramp Width (in)	48.0	No	Ramp XSlope (%)	8.0		
N/A	Flare Type LT	N/A	N/A	Flare Type RT	N/A		
N/A	Flare Slope LT (%)	N/A	N/A	Flare Slope RT (%)	N/A		
N/A	Flare Traversable LT?	N/A	N/A	Flare Traversable RT?	N/A		
N/A	Landing Length (in)	N/A	N/A	DWS Provided?	N/A		
N/A	Landing Width (in)	N/A	N/A	DWS Contrast?	N/A		
N/A	Landing Slope (%)	N/A	N/A	DWS Length (in)	N/A		
N/A	Landing X Slope (%)	N/A	N/A	DWS Full Width?	N/A		
N/A	Landing Curb? (Y/N)	N/A	N/A	DWS Offset (in)	N/A		
N/A	Shared Landing?	N/A					
N/A	Gutter Ponding?	N/A	N/A	Gutter Slope (%)	N/A		
N/A	Gutter Lip Ht (in)	N/A	N/A	Gutter X Slope (%)	N/A		
N/A	Painted X Walk1?	No	N/A	Painted X Walk2?	No		
	X Walk 1 Direction	To N		X Walk 2 Direction	To W		
N/A	X Walk 1 Width (in)	N/A	N/A	X Walk 2 Width (in)	N/A

X Walk 1 Slope (%)	3.3		X Walk 2 Slope (%)	2.4		
	X Walk 1 X Slope (%)	3.8		X Walk 2 X Slope (%)	4.8		
N/A	Ramp inside XWalk1?	N/A	N/A	Ramp inside XWalk2?	N/A		
	Road Slope (%)	5.4	N/A	Clear Space?	N/A		
	Road X Slope (%)	3.2	N/A	Clear Space to XWalk (in)	N/A		
N/A	Any Obstructions?	N/A	N/A	Storm Grate/Utility Hazard?	N/A		
	Obstruction Type			Storm Grate/Utility Type			
		N/A			N/A		
			Yes	Surface Condition? (G/P)	Good		
et la

0001810 001811011				
Possible Solutions:	<u>c</u>			
Remove & Replace Curb Ramp With				
Two New Directional Ramps or	Y			
Equivalent.				
	N			
	N			
	N			
Surveyor Notes:	N			
N/A	N			
	N			
	N			
	N			
PROW/ADA:	N			
Not Found, R304.5.3	N.			
	N			
	N			
	N
