Access Compliance Report Public Rights-of-Way (Curb Ramps)

Intersection ID: 20874Main Street:STEELE_CREEK_RDCross Street:WESTINGHOUSE_COMMONS_DRLocation:NEADA ID: 9E3863092931Ramp Type:Directional1Initial Pass/Fail:FailOverall Compliance:NoSeverity Score:1.25

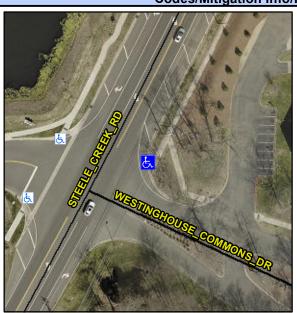
1 Ossible Solution		i iciu ivicas
Possible Solutions:	Compli	ance Description
Remove & Replace Entire Ramp.	N/A	Ramp Length (in)
·	Yes	Ramp Width (in)
	Yes	Ramp Slope (%)
	No	Ramp XSlope (%)
	N/A	Flare Type LT
	N/A	Flare Slope LT (%)
Surveyor Notes:	N/A	Flare Traversable LT?
N/A	N/A	Landing Length (in)
	N/A	Landing Width (in)
	N/A	Landing Slope (%)
	N/A	Landing X Slope (%)
PROW/ADA:	N/A	Landing Curb? (Y/N)
R304.5.3	N/A	Shared Landing?
	N/A	Gutter Ponding?
	N/A	Gutter Lip Ht (in)
	N/A	Painted X Walk1?
		X Walk 1 Direction
		X Walk 1 Width (in)
		X Walk 1 Slope (%)
		X Walk 1 X Slope (%)
	N/A	Ramp inside XWalk1?
