Access Compliance Report

Public Rights-of-Way

(Curb Ramps)

Intersection ID: 8852	Main Street: DOGWOOD_AV	Cross Street: GRIMES_ST	Location: S
ADA ID: 9E3BAD538E3E	Ramp Type: Combination1	Initial Pass/Fail: Fail	Overall Compliance: No
		Severity Score: 10

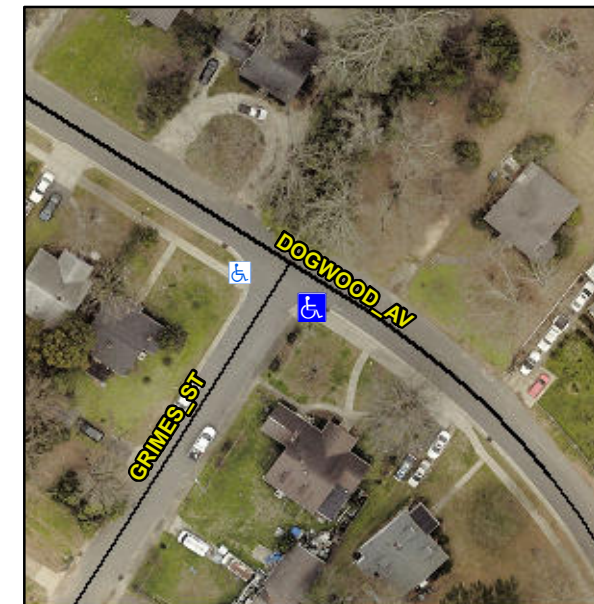
LT RP < 5%, RT RP < 5%

Not Found, R304.5.1, R304.5.3

Compliance	Description	Data	Compliance	Description	Data
N/A	Ramp Length LT (in)	27.0	N/A	Ramp Length RT (in)	32.5
No	Ramp Width LT (in)	47.5	No	Ramp Width RT (in)	36.0
Yes	Ramp Slope LT (%)	3.9	Yes	Ramp Slope RT (%)	0.1
Yes	Ramp XSlope LT (%)	2.0	Yes	Ramp XSlope RT (%)	1.0
N/A	Ramp Length (in)	29.0	Yes	Ramp Slope (%)	6.7
Yes	Ramp Width (in)	48.0	No	Ramp XSlope (%)	2.2
N/A	Flare Type LT	N/A	N/A	Flare Type RT	N/A
N/A	Flare Slope LT (%)	N/A	N/A	Flare Slope RT (%)	N/A
N/A	Flare Traversable LT?	N/A	N/A	Flare Traversable RT?	N/A
N/A	Landing Length (in)	N/A	N/A	DWS Provided?	N/A
N/A	Landing Width (in)	N/A	N/A	DWS Contrast?	N/A
N/A	Landing Slope (%)	N/A	N/A	DWS Length (in)	N/A
N/A	Landing X Slope (%)	N/A	N/A	DWS Full Width?	N/A
N/A	Landing Curb? (Y/N)	N/A	N/A	DWS Offset (in)	N/A
N/A	Shared Landing?	N/A			
N/A	Gutter Ponding?	N/A	N/A	Gutter Slope (%)	N/A
N/A	Gutter Lip Ht (in)	N/A	N/A	Gutter X Slope (%)	N/A
N/A	Painted X Walk1?	No	N/A	Painted X Walk2?	N/A

X Walk 1 Direction	To NW		X Walk 2 Direction	N/A
	X Walk 1 Width (in)	N/A		X Walk 2 Width (in)	N/A
	X Walk 1 Slope (%)	3.1		X Walk 2 Slope (%)	N/A
	X Walk 1 X Slope (%)	4.7		X Walk 2 X Slope (%)	N/A
N/A	Ramp inside XWalk1?	N/A	N/A	Ramp inside XWalk2?	N/A
	Road Slope (%)	N/A		Clear Space?	N/A
	Road X Slope (%)	N/A	N/A	Clear Space to XWalk (in)	N/A
			N/A	Any Obstruction?	N/A
				Obstruction Type	N/A
			N/A	Storm Grate/Utility Hazard?	N/A
				Storm Grate/Utility Type	N/A
Yes	Surface Condition? (G/P)	Good			
	Curb Slope (%)	8.0

Remove & Replace Entire Ramp.
