Intersection ID: 17916	Main Street: ROCKLYN_PL	Cross Street: WESTFIELD_RD	Location:	NW
ADA ID: 9E4611CC41B8	Ramp Type: Perp	Initial Pass/Fail: Fail	Overall Compliance: No	Severity Score: 12.5

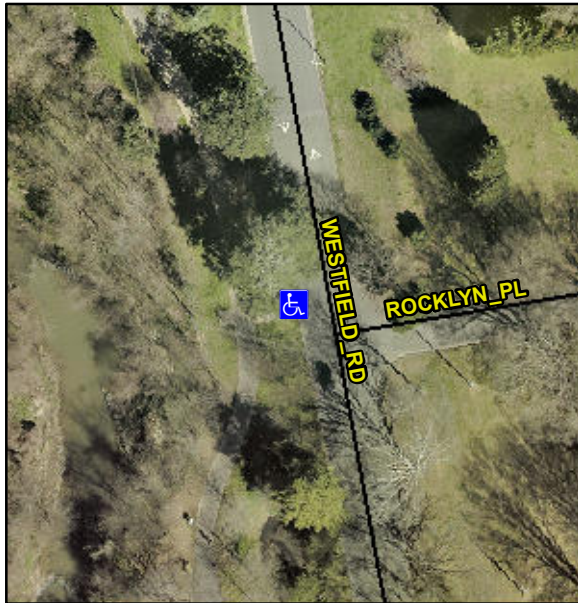
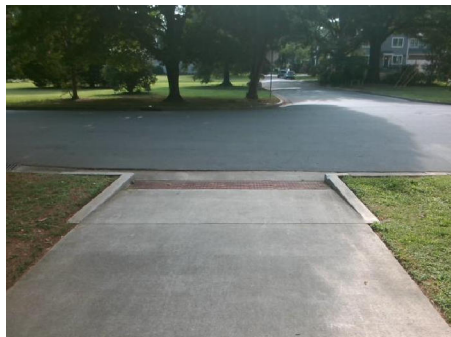
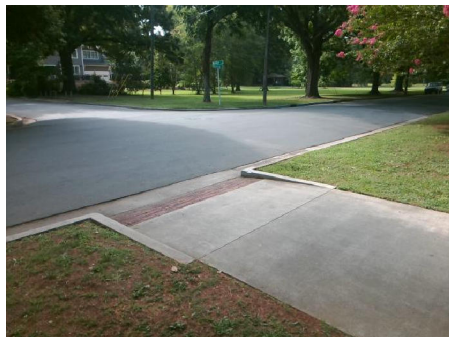
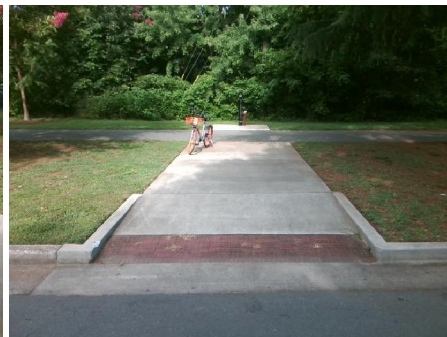
Possible Solutions:		Compliance	Description	Data	Compliance	Description	Data
<b>Remove &amp; Replace Entire Ramp.</b>		N/A	Ramp Length (in)	79.0	No	Ramp Slope (%)	10.7
		Yes	Ramp Width (in)	120.0	Yes	Ramp XSlope (%)	0.8
		N/A	Flare Type LT	N/A	N/A	Flare Type RT	N/A
		N/A	Flare Slope LT (%)	N/A	N/A	Flare Slope RT (%)	N/A
		N/A	Flare Traversable LT?	N/A	N/A	Flare Traversable RT?	N/A
		N/A	Landing Length (in)	N/A	N/A	DWS Provided?	N/A
Surveyor Notes:		N/A	Landing Width (in)	N/A	N/A	DWS Contrast?	N/A
<b>N/A</b>		N/A	Landing Slope (%)	N/A	N/A	DWS Length (in)	N/A
		N/A	Landing X Slope (%)	N/A	N/A	DWS Full Width?	N/A
		N/A	Landing Curb? (Y/N)	N/A	N/A	DWS Offset (in)	N/A
		N/A	Shared Landing?	N/A			
PROW/ADA:		N/A	Gutter Ponding?	N/A	N/A	Gutter Slope (%)	N/A
<b>R304.2.2</b>		N/A	Gutter Lip Ht (in)	N/A	N/A	Gutter X Slope (%)	N/A
		N/A	Painted X Walk1?	No	N/A	Painted X Walk2?	N/A
			X Walk 1 Direction	To E		X Walk 2 Direction	N/A

N/A	X Walk 1 Width (in)	N/A	N/A	X Walk 2 Width (in)	N/A
			X Walk 1 Slope (%)	10.4		X Walk 2 Slope (%)	N/A
			X Walk 1 X Slope (%)	1.6		X Walk 2 X Slope (%)	N/A
		N/A	Ramp inside XWalk1?	N/A	N/A	Ramp inside XWalk2?	N/A
			Road Slope (%)	N/A	N/A	Clear Space?	N/A
			Road X Slope (%)	N/A	N/A	Clear Space to XWalk (in)	N/A
		N/A	Any Obstructions?	N/A	N/A	Storm Grate/Utility Hazard?	N/A
Total Cost:	\$ 1850.00		Obstruction Type			Storm Grate/Utility Type	
				N/A			N/A
					Yes	Surface Condition? (G/P)	Good

### Remove & Replace Entire Ramp.

Total Cost: \$ 1850.00
