# Access Compliance Report

## Public Rights-of-Way

### (Curb Ramps)

| Intersection ID: N/A | Main Street: RED_RUST_LN | Cross Street: COYOTE_LN | Location: NW |

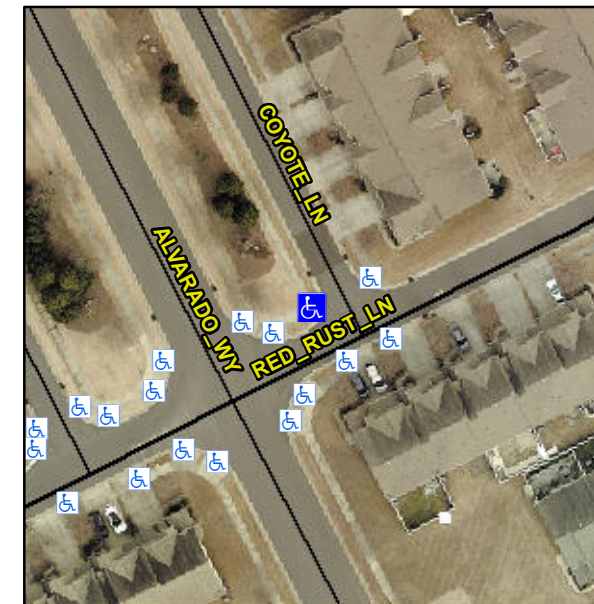
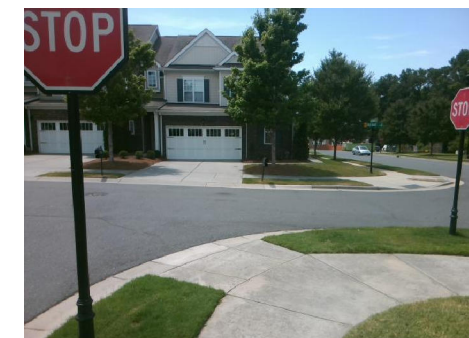
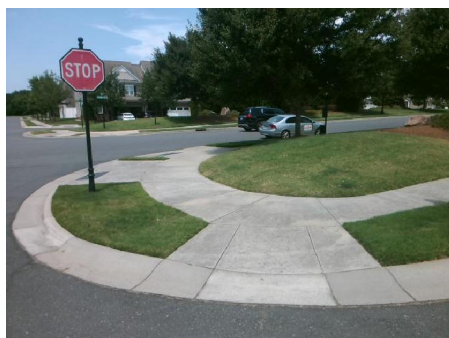
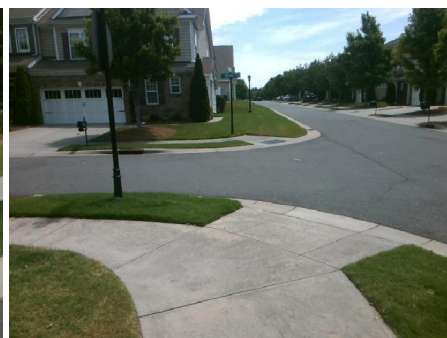
| ADA ID: 9E64E9021EB0 | Ramp Type: PerpDiag | Initial Pass/Fail: Fail | Overall Compliance: No |

**Not Found, R304.5.1, R304.2.2, R304.5.3**

| Compliance | Description | Data | Compliance | Description | Data |
|---|---|---|---|---|---|
| N/A | Ramp Length (in) | 52.0 | No | Ramp Slope (%) | 8.7 |
| No | Ramp Width (in) | 38.5 | No | Ramp XSlope (%) | 4.6 |

**Remove & Replace Curb Ramp With Two New Directional Ramps or Equivalent.**
