Access Compliance Report

Public Rights-of-Way

(Curb Ramps)

Intersection ID: 30323	Main Street: SHINKANSEN_DR	Cross Street: STOURBRIDGE_LION_DR	Location: N
ADA ID: 9E7E42B14CE0	Ramp Type: PerpDiag	Initial Pass/Fail: Fail	Overall Compliance: No
Codes/Mitigation Info/Possible Solution		Field Measurements/Component Compliance

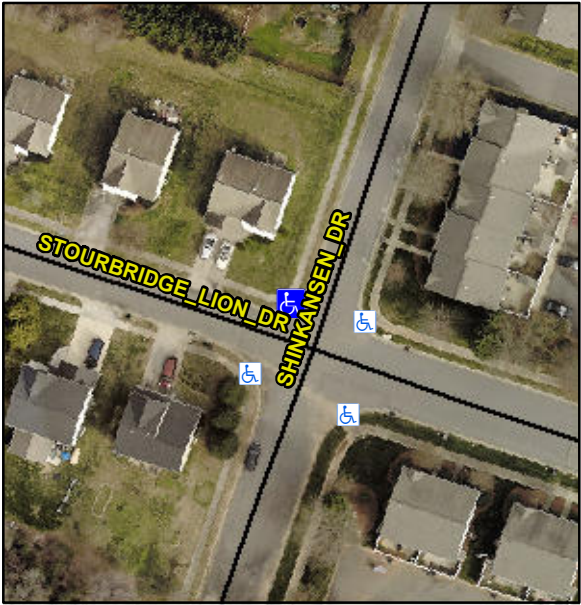
Possible Solutions:	Compliance	Description	Data	Compliance	Description	Data
	Remove & Replace Curb Ramp With Two New Directional Ramps or Equivalent.	N/A	Ramp Length (in)	47.5	No	Ramp Slope (%)	14.4
<p>Surveyor Notes:</p> <p>N/A</p> <p>PROW/ADA:</p> <p>Not Found, R304.5.1, R304.2.2, R304.5.3</p>		No	Ramp Width (in)	38.5	No	Ramp XSlope (%)	7.0
		N/A	Flare Type LT	N/A	N/A	Flare Type RT	N/A
		N/A	Flare Slope LT (%)	N/A	N/A	Flare Slope RT (%)	N/A
		N/A	Flare Traversable LT?	N/A	N/A	Flare Traversable RT?	N/A
		N/A	Landing Length (in)	N/A	N/A	DWS Provided?	N/A
		N/A	Landing Width (in)	N/A	N/A	DWS Contrast?	N/A
		N/A	Landing Slope (%)	N/A	N/A	DWS Length (in)	N/A
		N/A	Landing X Slope (%)	N/A	N/A	DWS Full Width?	N/A
		N/A	Landing Curb? (Y/N)	N/A	N/A	DWS Offset (in)	N/A
		N/A	Shared Landing?	N/A			
		N/A	Gutter Ponding?	N/A	N/A	Gutter Slope (%)	N/A
		N/A	Gutter Lip Ht (in)	N/A	N/A	Gutter X Slope (%)	N/A
		N/A	Painted X Walk1?	No	N/A	Painted X Walk2?	No

X Walk 1 Direction	To W		X Walk 2 Direction	To E
		N/A	X Walk 1 Width (in)	N/A	N/A	X Walk 2 Width (in)	N/A
			X Walk 1 Slope (%)	0.3		X Walk 2 Slope (%)	5.4
			X Walk 1 X Slope (%)	6.1		X Walk 2 X Slope (%)	3.2
		N/A	Ramp inside XWalk1?	N/A	N/A	Ramp inside XWalk2?	N/A
			Road Slope (%)	5.9	N/A	Clear Space?	N/A
			Road X Slope (%)	3.6	N/A	Clear Space to XWalk (in)	N/A
		N/A	Any Obstructions?	N/A	N/A	Storm Grate/Utility Hazard?	N/A
			Obstruction Type			Storm Grate/Utility Type	
				N/A			N/A
					Yes	Surface Condition? (G/P)	Good
