# Access Compliance Report

## Public Rights-of-Way

### (Curb Ramps)

| Intersection ID: 27468 | Main Street: BALLANTYNE COMMONS PY | Cross Street: JOHN J DELANEY DR | Location: SE |

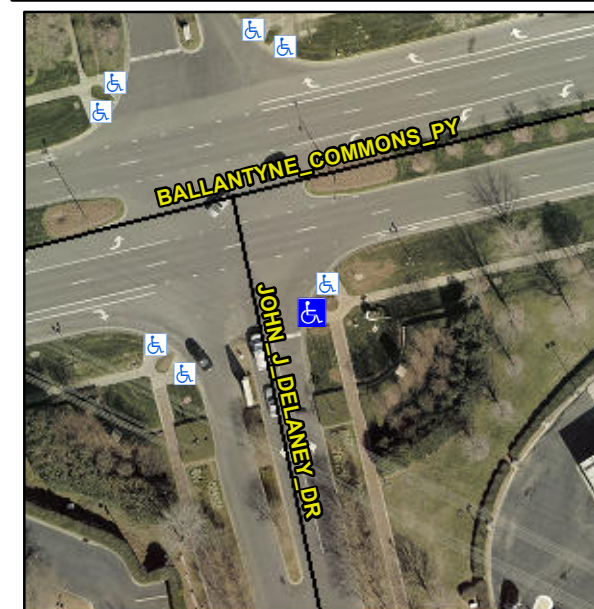
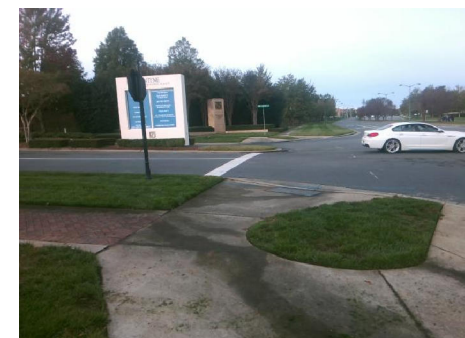
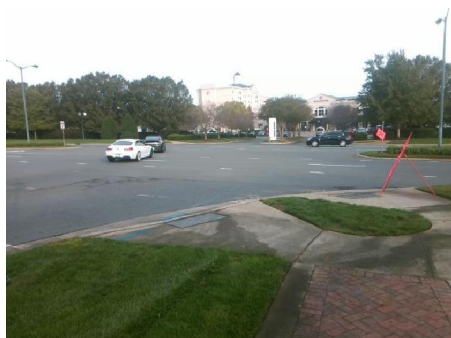
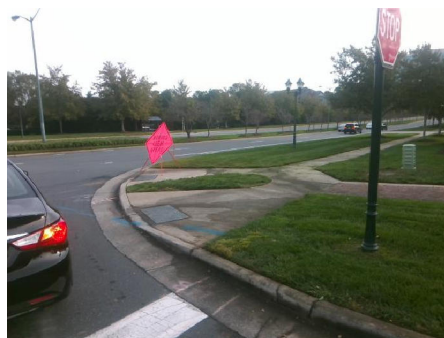
| ADA ID: 9E9D301EE18F | Ramp Type: BlendTrans1 | Initial Pass/Fail: Fail | Overall Compliance: No |

| Severity Score: 8.75 | | | |

**R304.5.1**

| Compliance | Description | Data | Compliance | Description | Data |
|---|---|---|---|---|---|
| No | Ramp Width (in) | 46.0 | Yes | BlendTrans XSlope (%) | 2.0 |

**Remove & Replace Curb Ramp With Two New Directional Ramps or Equivalent.**

Total Cost: \$ 3200.00
