Access Compliance Report Public Rights-of-Way (Curb Ramps)

Intersection ID: 6917 Main Street: GRIERS GROVE RD Cross Street: MERRILL PL Location: W **ADA ID: 9EA03654F8EC** Ramp Type: Perp Initial Pass/Fail: Fail **Overall Compliance: No Severity Score:** 10

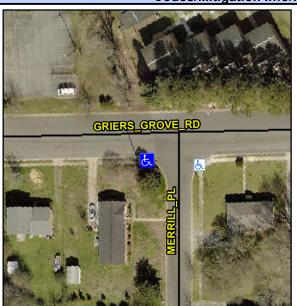
MERRILL PL Street 1 Name Stop Condition-Street 2 StopSign Street 2 Name N/A Stop Condition-Street 1 N/A Possible Solutions: Cor N/A Remove & Replace Entire Ramp. No N/A N/A N/A N/A Surveyor Notes: N/A N/A N/A PROW/ADA: Not Found, R304.5.1, R304.5.3

| omp | liance Description | Data | Comp | liance Description | Data |
|---|---|---|---|---|---|
| Α | Ramp Length (in) | 61.0 | Yes | Ramp Slope (%) | 5.1 |
|) | Ramp Width (in) | 47.0 | No | Ramp XSlope (%) | 2.7 |

N/A N/A N/A N/A N/A N/A N/A N/A N/A Total Cost: 1850.00
