Access Compliance Report

Public Rights-of-Way

(Curb Ramps)

Intersection ID: 9796	Main Street: BARRINGTON_DR	Cross Street: MONTEGO_DR	Location: SW
ADA ID: 9EA6496018DA	Ramp Type: Perp	Initial Pass/Fail: Fail	Overall Compliance: No
Severity Score: 33.75			
Codes/Mitigation Info/Possible Solution		Field Measurements/Component Compliance

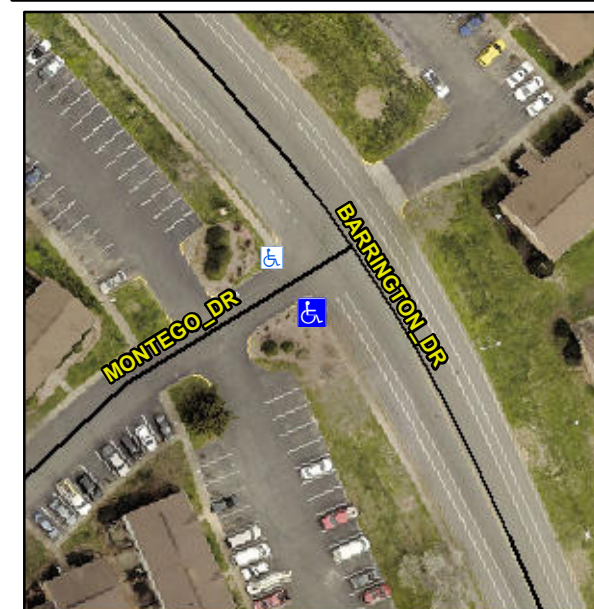
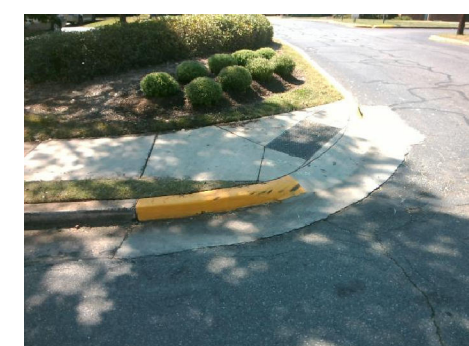
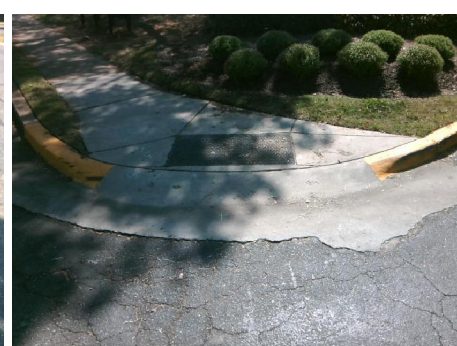
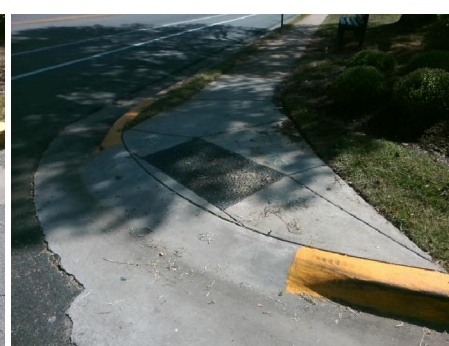
Not Found, R304.5.1, R304.5.3

Compliance	Description	Data	Compliance	Description	Data
N/A	Ramp Length (in)	27.0	Yes	Ramp Slope (%)	6.1
No	Ramp Width (in)	47.5	No	Ramp XSlope (%)	7.3
N/A	Flare Type LT	N/A	N/A	Flare Type RT	N/A
N/A	Flare Slope LT (%)	N/A	N/A	Flare Slope RT (%)	N/A
N/A	Flare Traversable LT?	N/A	N/A	Flare Traversable RT?	N/A
N/A	Landing Length (in)	N/A	N/A	DWS Provided?	N/A
N/A	Landing Width (in)	N/A	N/A	DWS Contrast?	N/A
N/A	Landing Slope (%)	N/A	N/A	DWS Length (in)	N/A
N/A	Landing X Slope (%)	N/A	N/A	DWS Full Width?	N/A
N/A	Landing Curb? (Y/N)	N/A	N/A	DWS Offset (in)	N/A
N/A	Shared Landing?	N/A			
N/A	Gutter Ponding?	N/A	N/A	Gutter Slope (%)	N/A
N/A	Gutter Lip Ht (in)	0.75	N/A	Gutter X Slope (%)	N/A
N/A	Painted X Walk1?	No	N/A	Painted X Walk2?	N/A
	X Walk 1 Direction	To NW		X Walk 2 Direction	N/A
N/A	X Walk 1 Width (in)	N/A	N/A	X Walk 2 Width (in)	N/A
	X Walk 1 Slope (%)	4.5		X Walk 2 Slope (%)	N/A
	X Walk 1 X Slope (%)	6.9		X Walk 2 X Slope (%)	N/A

N/A	Ramp inside XWalk1?	N/A	N/A	Ramp inside XWalk2?	N/A
	Road Slope (%)	N/A	N/A	Clear Space?	N/A
	Road X Slope (%)	N/A	N/A	Clear Space to XWalk (in)	N/A
N/A	Any Obstructions?	N/A	N/A	Storm Grate/Utility Hazard?	N/A
	Obstruction Type			Storm Grate/Utility Type	
		N/A			N/A
			Yes	Surface Condition? (G/P)	Good

Remove & Replace Entire Ramp.
