Access Compliance Report Public Rights-of-Way (Curb Ramps)

Intersection ID: 7621 Main Street: N_I-85_EXIT_39_RA		Cross St	Cross Street: STATESVILLE_AV				Location:	NW	
ADA ID: 9EA7DF0EADCB Ramp Type: Perp		Initial Pa	Initial Pass/Fail: Fail Overall Compliance: No				o Severity Score:	26.25	
Codes/Mitigation Info/Possible Solution			Field Measurements/Component Compliance						
	Possible Solutions:					a Compliance Description		Data	
	Remove & Replace Entire Ram	р.	N/A	Ramp Length (in)	44.0	No	Ramp Slope (%)	14.2	
	学家	•	Yes	Ramp Width (in)	60.0	No	Ramp XSlope (%)	3.6	
	Contraction of the second s	1	N/A	Flare Type LT	N/A	N/A	Flare Type RT	N/A	
		1	N/A	Flare Slope LT (%)	N/A	N/A	Flare Slope RT (%)	N/A	
		1	N/A	Flare Traversable LT?	N/A	N/A	Flare Traversable RT?	N/A	
S S S S S S S S S S S S S S S S S S S	·	1	N/A	Landing Length (in)	N/A	N/A	DWS Provided?	N/A	
	Surveyor Notes:	1	N/A	Landing Width (in)	N/A	N/A	DWS Contrast?	N/A	
N 1-00 EXIT 39 RA	N/A	1	N/A	Landing Slope (%)	N/A	N/A	DWS Length (in)	N/A

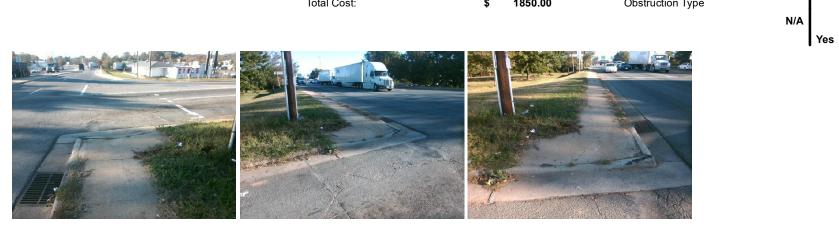
- L	PROW/ADA:	1	N/A	Gutter Ponding?	N/A	N/A	Gutter Slope (%)	1.9	
A BURNER AND A BURNER	Not Found, R304.2.2, R304.5.3		N/A	Gutter Lip Ht (in)	N/A	N/A	Gutter X Slope (%)	2.3	
		1	N/A	Painted X Walk1?	No	N/A	Painted X Walk2?	N/A	
	1000			X Walk 1 Direction	To S		X Walk 2 Direction	N/A	
		1	N/A	X Walk 1 Width (in)	N/A	N/A	X Walk 2 Width (in)	N/A	
Street 1 Name N I-85 EXIT	 Г 39 RA			X Walk 1 Slope (%)	1.5		X Walk 2 Slope (%)	N/A	
Stop Condition-Street 2	Signal			X Walk 1 X Slope (%)	1.9		X Walk 2 X Slope (%)	N/A	
Street 2 Name	N/A	1	N/A	Ramp inside XWalk1?	N/A	N/A	Ramp inside XWalk2?	N/A	
Stop Condition-Street 1	N/A			Road Slope (%)	N/A	N/A	Clear Space?	N/A	
				Road X Slope (%)	N/A	N/A	Clear Space to XWalk (in)	N/A	
		I	N/A	Any Obstructions?	N/A	N/A	Storm Grate/Utility Hazard?	N/A	
	Total Cost: \$	1850.00		Obstruction Type			Storm Grate/Utility Type		
					N/A			N/A
