## **Access Compliance Report Public Rights-of-Way** (Curb Ramps)

Intersection ID: 23180 Main Street: ELFREDA RD **Cross Street: OBERWOOD DR** Location: SW ADA ID: 9EC48F816753 Ramp Type: PerpDiag Initial Pass/Fail: Fail **Overall Compliance: No Severity Score:** 25

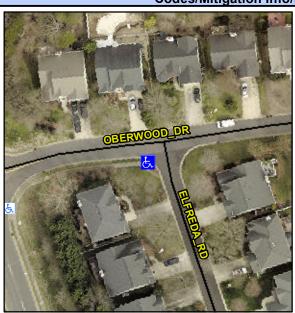
Field Measurements/Component Compliance							
	Compl	Compliance Description		Compliance		Description	Data
	N/A	Ramp Length (in)	49.0	No	Ramp	Slope (%)	8.8
	Yes	Ramp Width (in)	48.0	No	Ram	XSlope (%)	6.1
	N/A	Flare Type LT	N/A	N/A	Flare	Type RT	N/A
	N/A	Flare Slope LT (%)	N/A	N/A	Flare	Slope RT (%)	N/A
	N/A	Flare Traversable LT?	N/A	N/A	Flare	Traversable RT?	N/A
	N/A	Landing Length (in)	N/A	N/A	DWS	Provided?	N/A
	N/A	Landing Width (in)	N/A	N/A	DWS	Contrast?	N/A
	N/A	Landing Slope (%)	N/A	N/A	DWS	Length (in)	N/A
	N/A	Landing X Slope (%)	N/A	N/A	DWS	Full Width?	N/A
	N/A	Landing Curb? (Y/N)	N/A	N/A	DWS	Offset (in)	N/A
	N/A	Shared Landing?	N/A				
	N/A	Gutter Ponding?	N/A	N/A	Gutte	er Slope (%)	N/A
	N/A	Gutter Lip Ht (in)	N/A	N/A	Gutte	r X Slope (%)	N/A
	N/A	Painted X Walk1?	No	N/A	Paint	ed X Walk2?	No
		X Walk 1 Direction	To E		X Wa	lk 2 Direction	To N
	N/A	X Walk 1 Width (in)	N/A	N/A	X Wa	lk 2 Width (in)	N/A

X Walk 1 Slope (%)	4.5		X Wa	lk 2 Slope (%)	3.2
		X Walk 1 X Slope (%)	1.4		X Wa	lk 2 X Slope (%)	2.0
	N/A	Ramp inside XWalk1?	N/A	N/A	Ram	inside XWalk2?	N/A
		Road Slope (%)	5.8	N/A	Clear	Space?	N/A
		Road X Slope (%)	5.5	N/A	Clear	Space to XWalk (in)	N/A
	N/A	Any Obstructions?	N/A	N/A	Storn	n Grate/Utility Hazard?	N/A
		Obstruction Type			Storn	n Grate/Utility Type	
			N/A				N/A
				Yes	Surfa	ce Condition? (G/P)	Good
		A STATE OF THE STA		-

Possible Solutions: Remove & Replace Curb Ramp With Two New Directional Ramps or Equivalent. Surveyor Notes: N/A PROW/ADA: R304.2.2, R304.5.3
