Access Compliance Report

Public Rights-of-Way

(Curb Ramps)

Intersection ID: 47854	Main Street: ADOBE_RD	Cross Street: CACTUS_VALLEY_RD	Location: NW
ADA ID: 9EC822D48940	Ramp Type: PerpDiag	Initial Pass/Fail: Fail	Overall Compliance: No
		Severity Score: 8.75

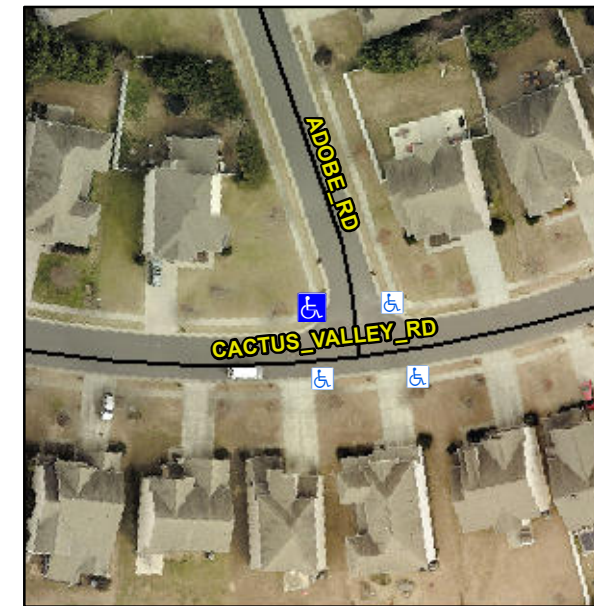
Not Found, R304.5.1

Compliance	Description	Data	Compliance	Description	Data
N/A	Ramp Length (in)	47.0	Yes	Ramp Slope (%)	5.9
No	Ramp Width (in)	47.0	Yes	Ramp XSlope (%)	0.9
N/A	Flare Type LT	N/A	N/A	Flare Type RT	N/A
N/A	Flare Slope LT (%)	N/A	N/A	Flare Slope RT (%)	N/A
N/A	Flare Traversable LT?	N/A	N/A	Flare Traversable RT?	N/A
N/A	Landing Length (in)	N/A	N/A	DWS Provided?	N/A
N/A	Landing Width (in)	N/A	N/A	DWS Contrast?	N/A
N/A	Landing Slope (%)	N/A	N/A	DWS Length (in)	N/A
N/A	Landing X Slope (%)	N/A	N/A	DWS Full Width?	N/A
N/A	Landing Curb? (Y/N)	N/A	N/A	DWS Offset (in)	N/A
N/A	Shared Landing?	N/A			
N/A	Gutter Ponding?	N/A	N/A	Gutter Slope (%)	N/A
N/A	Gutter Lip Ht (in)	N/A	N/A	Gutter X Slope (%)	N/A
N/A	Painted X Walk1?	No	N/A	Painted X Walk2?	No
	X Walk 1 Direction	To S		X Walk 2 Direction	To E
N/A	X Walk 1 Width (in)	N/A	N/A	X Walk 2 Width (in)	N/A
	X Walk 1 Slope (%)	0.1		X Walk 2 Slope (%)	1.5
	X Walk 1 X Slope (%)	1.1		X Walk 2 X Slope (%)	0.2

Remove & Replace Curb Ramp With Two New Directional Ramps or Equivalent.
