# Access Compliance Report

## Public Rights-of-Way

### (Curb Ramps)

| Intersection ID: 26384 | Main Street: BEVINGTON_PL | Cross Street: ELM_LN | Location: NE |

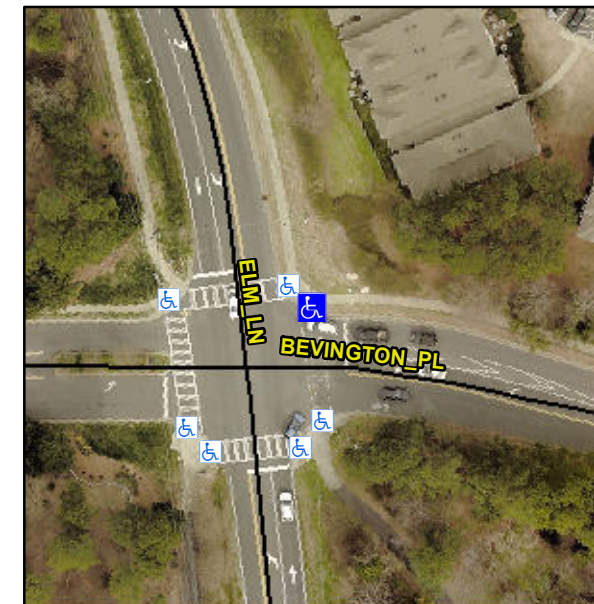
| ADA ID: 9ED1C5C8195E | Ramp Type: Perp | Initial Pass/Fail: Fail | Overall Compliance: No |

**R304.2.2, R304.5.3**

| Compliance | Description | Data | Compliance | Description | Data |
|---|---|---|---|---|---|
| N/A | Ramp Length (in) | 62.0 | No | Ramp Slope (%) | 9.1 |
| Yes | Ramp Width (in) | 48.0 | No | Ramp XSlope (%) | 5.1 |

**Remove & Replace Entire Ramp.**

Total Cost: \$ 1850.00
