# Access Compliance Report

## Public Rights-of-Way

### (Curb Ramps)

Intersection ID: 12063	Main Street: HAWTHORNE_LN	Cross Street: KENNON_ST	Location: NW
ADA ID: 9ED5C28CD82A	Ramp Type: PerpDiag	Initial Pass/Fail: Fail	Overall Compliance: No
		Severity Score: 22.5

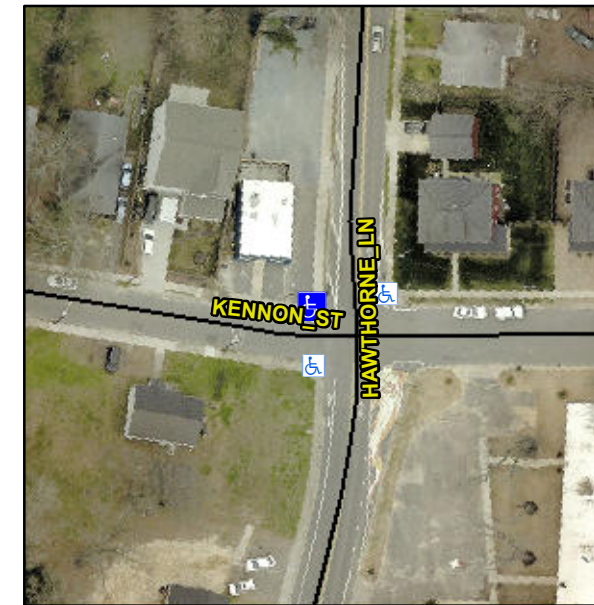
**Not Found, R304.5.1, R304.2.2, R304.5.3**

Compliance	Description	Data	Compliance	Description	Data
N/A	Ramp Length (in)	58.0	No	Ramp Slope (%)	10.4
No	Ramp Width (in)	43.0	No	Ramp XSlope (%)	3.1
N/A	Flare Type LT	N/A	N/A	Flare Type RT	N/A
N/A	Flare Slope LT (%)	N/A	N/A	Flare Slope RT (%)	N/A
N/A	Flare Traversable LT?	N/A	N/A	Flare Traversable RT?	N/A
N/A	Landing Length (in)	N/A	N/A	DWS Provided?	N/A
N/A	Landing Width (in)	N/A	N/A	DWS Contrast?	N/A
N/A	Landing Slope (%)	N/A	N/A	DWS Length (in)	N/A
N/A	Landing X Slope (%)	N/A	N/A	DWS Full Width?	N/A
N/A	Landing Curb? (Y/N)	N/A	N/A	DWS Offset (in)	N/A
N/A	Shared Landing?	N/A			
N/A	Gutter Ponding?	N/A	N/A	Gutter Slope (%)	N/A
N/A	Gutter Lip Ht (in)	N/A	N/A	Gutter X Slope (%)	N/A
N/A	Painted X Walk1?	No	N/A	Painted X Walk2?	No
	X Walk 1 Direction	To S		X Walk 2 Direction	To E
N/A	X Walk 1 Width (in)	N/A	N/A	X Walk 2 Width (in)	N/A
	X Walk 1 Slope (%)	2.0		X Walk 2 Slope (%)	5.0
	X Walk 1 X Slope (%)	1.5		X Walk 2 X Slope (%)	0.9

N/A	Ramp inside XWalk1?	N/A	N/A	Ramp inside XWalk2?	N/A
	Road Slope (%)	2.1	N/A	Clear Space?	N/A
	Road X Slope (%)	4.6	N/A	Clear Space to XWalk (in)	N/A
N/A	Any Obstructions?	N/A	N/A	Storm Grate/Utility Hazard?	N/A
	Obstruction Type			Storm Grate/Utility Type	
		N/A			N/A
			Yes	Surface Condition? (G/P)	Good

**Remove & Replace Curb Ramp With Two New Directional Ramps or Equivalent.**
