# Access Compliance Report

## Public Rights-of-Way

### (Curb Ramps)

Intersection ID: 9362	Main Street: DELTA_LAKE_DR	Cross Street: ROCKMOOR_RIDGE_RD	Location: SE
ADA ID: 9EDA418B17F7	Ramp Type: PerpDiag	Initial Pass/Fail: Fail	Overall Compliance: No
Severity Score: 10			
Codes/Mitigation Info/Possible Solution		Field Measurements/Component Compliance

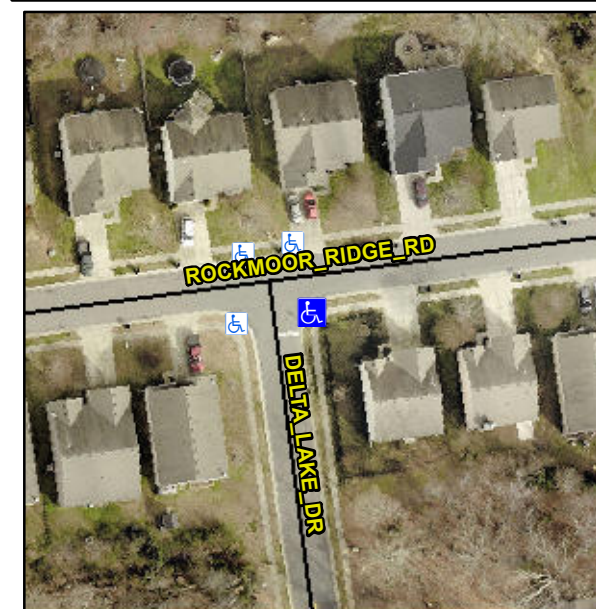
**Not Found, R304.5.1, R304.5.3**

Compliance	Description	Data	Compliance	Description	Data
N/A	Ramp Length (in)	45.5	Yes	Ramp Slope (%)	5.2
No	Ramp Width (in)	47.5	No	Ramp XSlope (%)	4.8
N/A	Flare Type LT	N/A	N/A	Flare Type RT	N/A
N/A	Flare Slope LT (%)	N/A	N/A	Flare Slope RT (%)	N/A
N/A	Flare Traversable LT?	N/A	N/A	Flare Traversable RT?	N/A
N/A	Landing Length (in)	N/A	N/A	DWS Provided?	N/A
N/A	Landing Width (in)	N/A	N/A	DWS Contrast?	N/A
N/A	Landing Slope (%)	N/A	N/A	DWS Length (in)	N/A
N/A	Landing X Slope (%)	N/A	N/A	DWS Full Width?	N/A
N/A	Landing Curb? (Y/N)	N/A	N/A	DWS Offset (in)	N/A
N/A	Shared Landing?	N/A			
N/A	Gutter Ponding?	N/A	N/A	Gutter Slope (%)	N/A
N/A	Gutter Lip Ht (in)	N/A	N/A	Gutter X Slope (%)	N/A
N/A	Painted X Walk1?	No	N/A	Painted X Walk2?	No
	X Walk 1 Direction	To N		X Walk 2 Direction	To W
N/A	X Walk 1 Width (in)	N/A	N/A	X Walk 2 Width (in)	N/A
	X Walk 1 Slope (%)	3.4		X Walk 2 Slope (%)	0.8
	X Walk 1 X Slope (%)	3.3		X Walk 2 X Slope (%)	4.0

N/A	Ramp inside XWalk1?	N/A	N/A	Ramp inside XWalk2?	N/A
	Road Slope (%)	3.4	N/A	Clear Space?	N/A
	Road X Slope (%)	1.1	N/A	Clear Space to XWalk (in)	N/A
N/A	Any Obstructions?	N/A	N/A	Storm Grate/Utility Hazard?	N/A
	Obstruction Type			Storm Grate/Utility Type	
		N/A			N/A
		Yes		Surface Condition? (G/P)	Good

**Remove & Replace Curb Ramp With Two New Directional Ramps or Equivalent.**
