Access Compliance Report

Public Rights-of-Way

(Curb Ramps)

Intersection ID: 24356	Main Street: BEVERLY_CREST_BV	Cross Street: CAMAROSS_DR	Location: SE
ADA ID: 9EE8715BAD90	Ramp Type: Perp	Initial Pass/Fail: Fail	Overall Compliance: No
Severity Score: 8.75			
Codes/Mitigation Info/Possible Solution		Field Measurements/Component Compliance

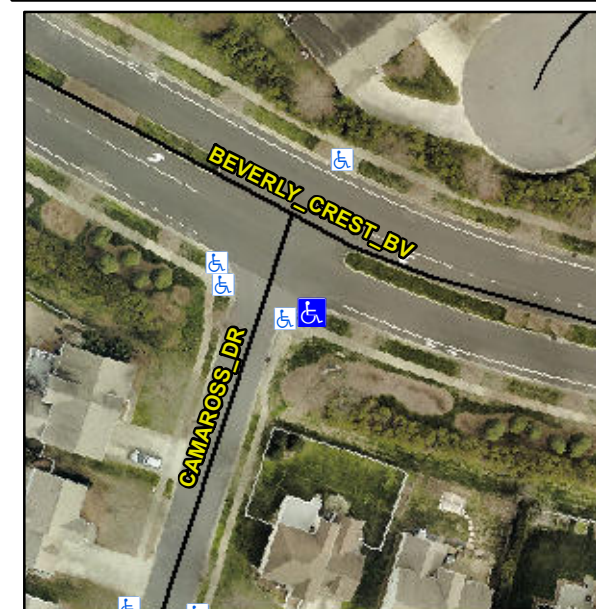
Not Found, R304.5.1

Compliance	Description	Data	Compliance	Description	Data
N/A	Ramp Length (in)	95.0	Yes	Ramp Slope (%)	7.7
No	Ramp Width (in)	40.5	Yes	Ramp XSlope (%)	1.1
N/A	Flare Type LT	N/A	N/A	Flare Type RT	N/A
N/A	Flare Slope LT (%)	N/A	N/A	Flare Slope RT (%)	N/A
N/A	Flare Traversable LT?	N/A	N/A	Flare Traversable RT?	N/A
N/A	Landing Length (in)	N/A	N/A	DWS Provided?	N/A
N/A	Landing Width (in)	N/A	N/A	DWS Contrast?	N/A
N/A	Landing Slope (%)	N/A	N/A	DWS Length (in)	N/A
N/A	Landing X Slope (%)	N/A	N/A	DWS Full Width?	N/A
N/A	Landing Curb? (Y/N)	N/A	N/A	DWS Offset (in)	N/A
N/A	Shared Landing?	N/A			
N/A	Gutter Ponding?	N/A	N/A	Gutter Slope (%)	N/A
N/A	Gutter Lip Ht (in)	N/A	N/A	Gutter X Slope (%)	N/A
N/A	Painted X Walk1?	No	N/A	Painted X Walk2?	N/A
	X Walk 1 Direction	To N		X Walk 2 Direction	N/A
N/A	X Walk 1 Width (in)	N/A	N/A	X Walk 2 Width (in)	N/A
	X Walk 1 Slope (%)	1.0		X Walk 2 Slope (%)	N/A
	X Walk 1 X Slope (%)	0.4		X Walk 2 X Slope (%)	N/A

N/A	Ramp inside XWalk1?	N/A	N/A	Ramp inside XWalk2?	N/A
	Road Slope (%)	N/A	N/A	Clear Space?	N/A
	Road X Slope (%)	N/A	N/A	Clear Space to XWalk (in)	N/A
N/A	Any Obstructions?	N/A	N/A	Storm Grate/Utility Hazard?	N/A
	Obstruction Type			Storm Grate/Utility Type	
		N/A			N/A
			Yes	Surface Condition? (G/P)	Good

Remove & Replace Entire Ramp.
