# Access Compliance Report

## Public Rights-of-Way

### (Curb Ramps)

Intersection ID: 11108	Main Street: TUCKASEEGEE_RD	Cross Street: N/A	Location: E
ADA ID: 9EE89C9BB67C	Ramp Type: Perp	Initial Pass/Fail: Fail	Overall Compliance: No
		Severity Score: 10

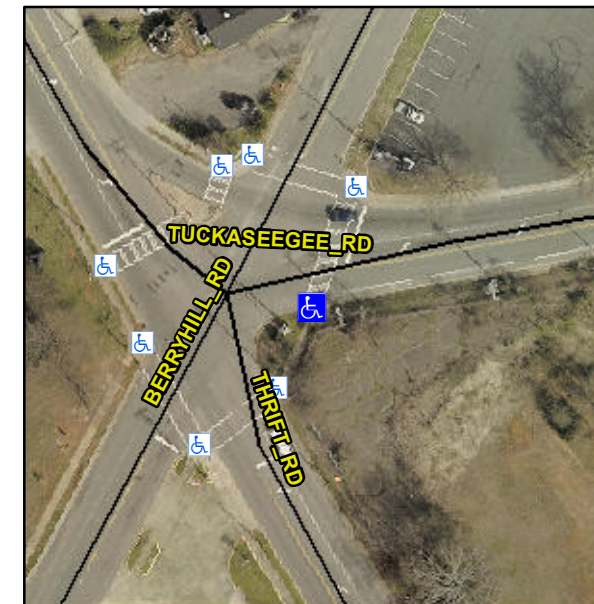
**Not Found, R304.5.1, R304.5.3**

Compliance	Description	Data	Compliance	Description	Data
N/A	Ramp Length (in)	60.0	Yes	Ramp Slope (%)	6.5
No	Ramp Width (in)	44.0	No	Ramp XSlope (%)	3.8
N/A	Flare Type LT	N/A	N/A	Flare Type RT	N/A
N/A	Flare Slope LT (%)	N/A	N/A	Flare Slope RT (%)	N/A
N/A	Flare Traversable LT?	N/A	N/A	Flare Traversable RT?	N/A
N/A	Landing Length (in)	N/A	N/A	DWS Provided?	N/A
N/A	Landing Width (in)	N/A	N/A	DWS Contrast?	N/A
N/A	Landing Slope (%)	N/A	N/A	DWS Length (in)	N/A
N/A	Landing X Slope (%)	N/A	N/A	DWS Full Width?	N/A
N/A	Landing Curb? (Y/N)	N/A	N/A	DWS Offset (in)	N/A
N/A	Shared Landing?	N/A			
N/A	Gutter Ponding?	N/A	N/A	Gutter Slope (%)	N/A
N/A	Gutter Lip Ht (in)	N/A	N/A	Gutter X Slope (%)	N/A
N/A	Painted X Walk1?	Yes	N/A	Painted X Walk2?	N/A
	X Walk 1 Direction	To NE		X Walk 2 Direction	N/A
N/A	X Walk 1 Width (in)	110.0	N/A	X Walk 2 Width (in)	N/A
	X Walk 1 Slope (%)	0.0		X Walk 2 Slope (%)	N/A
	X Walk 1 X Slope (%)	2.3		X Walk 2 X Slope (%)	N/A

N/A	Ramp inside XWalk1?	Yes	N/A	Ramp inside XWalk2?	N/A
	Road Slope (%)	N/A	N/A	Clear Space?	N/A
	Road X Slope (%)	N/A	N/A	Clear Space to XWalk (in)	N/A
N/A	Any Obstructions?	N/A	N/A	Storm Grate/Utility Hazard?	N/A
	Obstruction Type			Storm Grate/Utility Type	
		N/A			N/A
			Yes	Surface Condition? (G/P)	Good

**Remove & Replace Entire Ramp.**

Total Cost: \$ 1850.00
