Access Compliance Report

Public Rights-of-Way

(Curb Ramps)

Intersection ID: 14305	Main Street: WORTHINGTON_AV	Cross Street: CLEVELAND_AV	Location:	N
ADA ID: 9F51EE2B4C8A	Ramp Type: Directional1	Initial Pass/Fail: Fail	Overall Compliance: No	Severity Score: 1.25

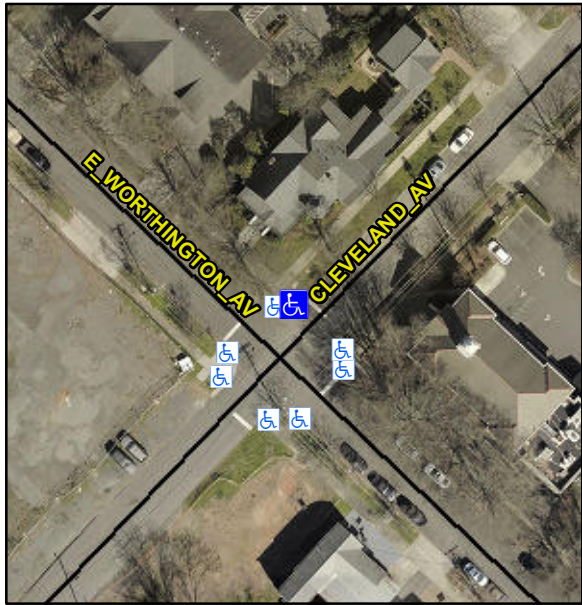
Possible Solutions:		Compliance			Description			Data	
	Remove & Replace Entire Ramp.		N/A	Ramp Length (in)	49.0	N/A	Grade Break?	N/A		
			Yes	Ramp Width (in)	60.0	N/A	Grade Break Slope (%)	0.0		
			Yes	Ramp Slope (%)	2.2	N/A	Grade Break XSlope (%)	0.0		
			No	Ramp XSlope (%)	2.3					
			N/A	Flare Type LT	N/A	N/A	Flare Type RT	N/A		
			N/A	Flare Slope LT (%)	N/A	N/A	Flare Slope RT (%)	0.0		
			N/A	Flare Traversable LT?	N/A	N/A	Flare Traversable RT?	N/A		
			N/A	Landing Length (in)	0.0	N/A	DWS Provided?	N/A		
			N/A	Landing Width (in)	0.0	N/A	DWS Contrast?	N/A		
		N/A	Landing Slope (%)	0.0	N/A	DWS Length (in)	N/A			
		N/A	Landing X Slope (%)	0.0	N/A	DWS Full Width?	N/A			
		N/A	Landing Curb? (Y/N)	N/A	N/A	DWS Offset LT (in)	N/A			
		N/A	Shared Landing?	N/A	N/A	DWS Offset RT (in)	N/A			
		N/A	Gutter Ponding?	0.0	N/A	Gutter Slope (%)	N/A

N/A	Gutter Lip Ht (in)	0.0	N/A	Gutter X Slope (%)	N/A			
		N/A	Painted X Walk1?	No		Road Slope (%)	0.9			
			X Walk 1 Direction	To SE		Road X Slope (%)	0.2			
			X Walk 1 Width (in)	N/A		Clear Space?	N/A			
			X Walk 1 Slope (%)	0.9	N/A	Clear Space to XWalk (in)	N/A			
			X Walk 1 X Slope (%)	0.2	N/A	Storm Grate/Utility Hazard?	N/A			
		N/A	Ramp inside XWalk1?	N/A		Storm Grate/Utility Type				
		N/A	Any Obstructions?	N/A			N/A			
			Obstruction Type		Yes	Surface Condition? (G/P)	Good			
					N/A	Curb Slope (%)	9.0			
Surveyor Notes:										
N/A										
PROW/ADA:										
R304.5.3										
Total Cost:		\$	1600.00							
Street 1 Name		CLEVELAND AV								
Stop Condition-Street 1		StopSign								
Street 2 Name		N/A								
Stop Condition-Street 2		N/A
