# Access Compliance Report

## Public Rights-of-Way

### (Curb Ramps)

| Intersection ID: 14513 | Main Street: N_CHASE_ST | Cross Street: VAIL_AV | Location: S |

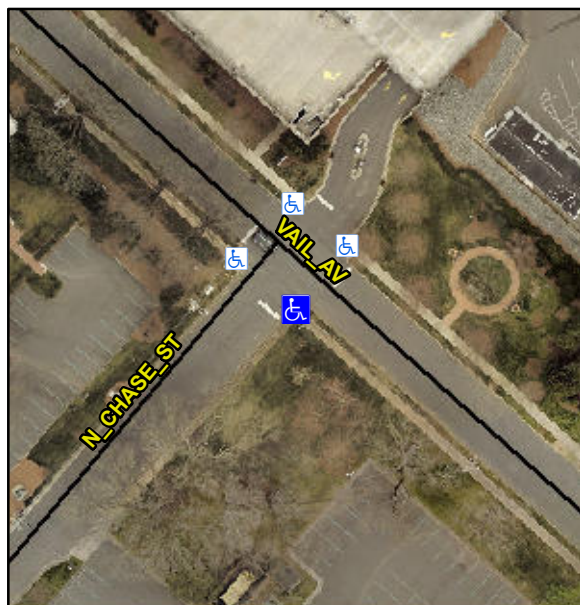
| ADA ID: 9F7391CF229B | Ramp Type: PerpDiag | Initial Pass/Fail: Fail | Overall Compliance: No |
| Severity Score: 1.25 | | | |

**Not Found, R304.5.3**

| Compliance | Description | Data | Compliance | Description | Data |
|---|---|---|---|---|---|
| Yes | Ramp Width (in) | 48.0 | No | Ramp XSlope (%) | 3.0 |

**Remove & Replace Curb Ramp With Two New Directional Ramps or Equivalent.**

Total Cost: \$ 3200.00
