# Access Compliance Report

## Public Rights-of-Way

### (Curb Ramps)

Intersection ID: 15223	Main Street: IDEAL_WY	Cross Street: SARAH_MARKS_AV	Location: SW
ADA ID: 9F8D24DB0FC7	Ramp Type: PerpDiag	Initial Pass/Fail: Fail	Overall Compliance: No
Severity Score: 12.5			
Codes/Mitigation Info/Possible Solution		Field Measurements/Component Compliance

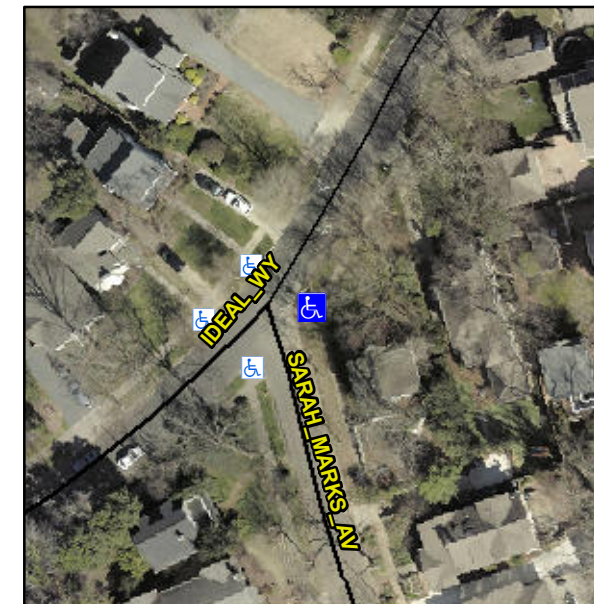
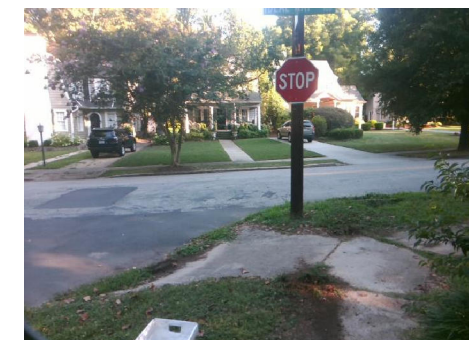
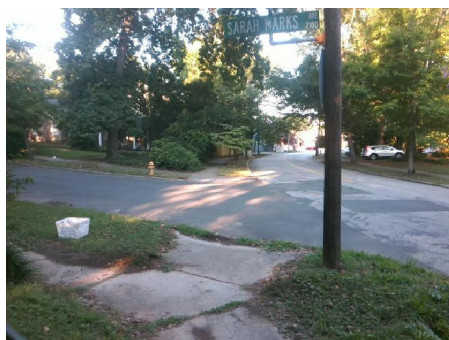
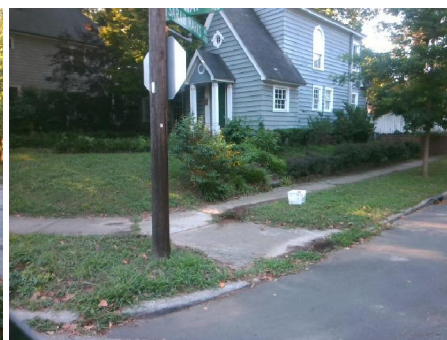
**Not Found, R304.2.2**

Compliance	Description	Data	Compliance	Description	Data
N/A	Ramp Length (in)	78.0	No	Ramp Slope (%)	9.5
Yes	Ramp Width (in)	76.0	Yes	Ramp XSlope (%)	0.7
N/A	Flare Type LT	N/A	N/A	Flare Type RT	N/A
N/A	Flare Slope LT (%)	N/A	N/A	Flare Slope RT (%)	N/A
N/A	Flare Traversable LT?	N/A	N/A	Flare Traversable RT?	N/A
N/A	Landing Length (in)	N/A	N/A	DWS Provided?	N/A
N/A	Landing Width (in)	N/A	N/A	DWS Contrast?	N/A
N/A	Landing Slope (%)	N/A	N/A	DWS Length (in)	N/A
N/A	Landing X Slope (%)	N/A	N/A	DWS Full Width?	N/A
N/A	Landing Curb? (Y/N)	N/A	N/A	DWS Offset (in)	N/A
N/A	Shared Landing?	N/A			
N/A	Gutter Ponding?	N/A	N/A	Gutter Slope (%)	N/A
N/A	Gutter Lip Ht (in)	N/A	N/A	Gutter X Slope (%)	N/A
N/A	Painted X Walk1?	No	N/A	Painted X Walk2?	No
	X Walk 1 Direction	To NW		X Walk 2 Direction	To SW
N/A	X Walk 1 Width (in)	N/A	N/A	X Walk 2 Width (in)	N/A
	X Walk 1 Slope (%)	4.0		X Walk 2 Slope (%)	1.4
	X Walk 1 X Slope (%)	0.9		X Walk 2 X Slope (%)	2.6

N/A	Ramp inside XWalk1?	N/A	N/A	Ramp inside XWalk2?	N/A
	Road Slope (%)	3.1	N/A	Clear Space?	N/A
	Road X Slope (%)	4.2	N/A	Clear Space to XWalk (in)	N/A
N/A	Any Obstructions?	N/A	N/A	Storm Grate/Utility Hazard?	N/A
	Obstruction Type			Storm Grate/Utility Type	
		N/A			N/A
			Yes	Surface Condition? (G/P)	Good

**Remove & Replace Curb Ramp With Two New Directional Ramps or Equivalent.**
