Access Compliance Report

Public Rights-of-Way

(Curb Ramps)

Intersection ID: 48556	Main Street: COTTON_PRESS_RD	Cross Street: BRANCHWATER_AV	Location: NW
ADA ID: 9F8DD0035663	Ramp Type: Perp	Initial Pass/Fail: Fail	Overall Compliance: No
Severity Score: 12.5			
Codes/Mitigation Info/Possible Solution		Field Measurements/Component Compliance

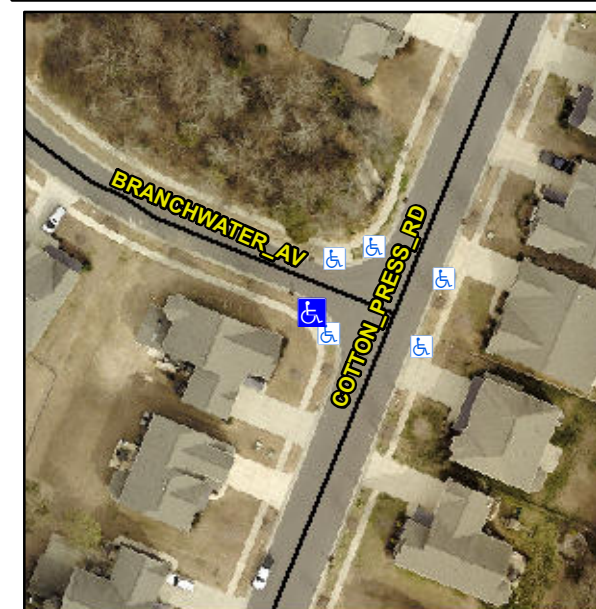
Not Found, R304.5.3

Compliance	Description	Data	Compliance	Description	Data
N/A	Ramp Length (in)	72.0	Yes	Ramp Slope (%)	5.6
Yes	Ramp Width (in)	48.0	No	Ramp XSlope (%)	5.2
N/A	Flare Type LT	N/A	N/A	Flare Type RT	N/A
N/A	Flare Slope LT (%)	N/A	N/A	Flare Slope RT (%)	N/A
N/A	Flare Traversable LT?	N/A	N/A	Flare Traversable RT?	N/A
N/A	Landing Length (in)	N/A	N/A	DWS Provided?	N/A
N/A	Landing Width (in)	N/A	N/A	DWS Contrast?	N/A
N/A	Landing Slope (%)	N/A	N/A	DWS Length (in)	N/A
N/A	Landing X Slope (%)	N/A	N/A	DWS Full Width?	N/A
N/A	Landing Curb? (Y/N)	N/A	N/A	DWS Offset (in)	N/A
N/A	Shared Landing?	N/A			
N/A	Gutter Ponding?	N/A	N/A	Gutter Slope (%)	N/A
N/A	Gutter Lip Ht (in)	N/A	N/A	Gutter X Slope (%)	N/A
N/A	Painted X Walk1?	No	N/A	Painted X Walk2?	N/A
	X Walk 1 Direction	To NE		X Walk 2 Direction	N/A
N/A	X Walk 1 Width (in)	N/A	N/A	X Walk 2 Width (in)	N/A
	X Walk 1 Slope (%)	2.5		X Walk 2 Slope (%)	N/A
	X Walk 1 X Slope (%)	3.4		X Walk 2 X Slope (%)	N/A

Possible Solutions:

Remove & Replace Entire Ramp.
