Access Compliance Report

Public Rights-of-Way

(Curb Ramps)

| Intersection ID: 14337 | Main Street: BERKELEY_AV | Cross Street: E_MOREHEAD_ST | Location: SW |

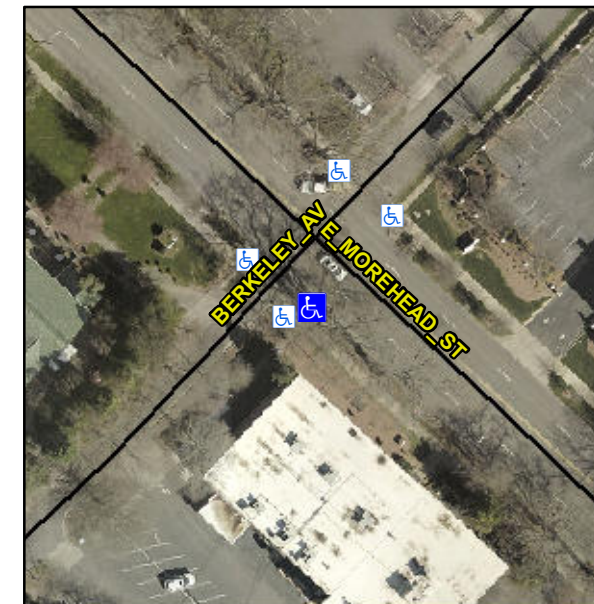
| ADA ID: 9F9F2AFAA924 | Ramp Type: Perp | Initial Pass/Fail: Fail | Overall Compliance: No |

Not Found, R304.5.3

| Compliance | Description | Data | Compliance | Description | Data |
|---|---|---|---|---|---|
| Yes | Ramp Width (in) | 54.0 | No | Ramp XSlope (%) | 5.9 |

Remove & Replace Entire Ramp.
