# Access Compliance Report

## Public Rights-of-Way

### (Curb Ramps)

| Intersection ID: 11194 | Main Street: FLAMINGO_AV | Cross Street: SPRINGWAY_DR | Location: NE |

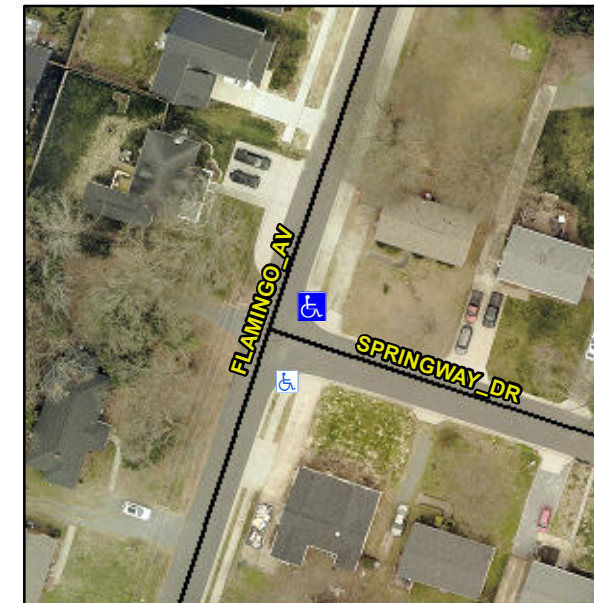
**RT RP < 5%**

**Not Found, R304.2.1, R304.5.3, R305.2**

| Compliance | Description | Data | Compliance | Description | Data |
|---|---|---|---|---|---|
| No | Landing Width (in) | 42.0 | Yes | DWS Contrast? | Yes |
| No | Landing X Slope (%) | 2.4 | Yes | DWS Full Width? | Yes |
| N/A | Landing Curb? (Y/N) | No | No | DWS Offset (in) | 3.0 |

**Remove & Replace Entire Ramp.**

Total Cost: \$ 1600.00
