# Access Compliance Report

## Public Rights-of-Way

Intersection ID: N/A	Main Street: S BREVARD ST	Cross Street: E 4TH ST	Location: S
ADA ID: 9FA6532308D9	Ramp Type: PerpDiag	Initial Pass/Fail: Fail	Overall Compliance: No
Severity Score: 46.25			
Codes/Mitigation Info/Possible Solution		Field Measurements/Component Compliance

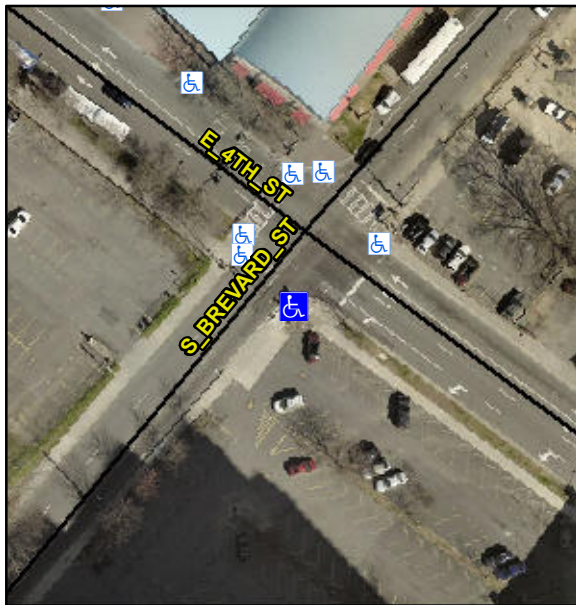
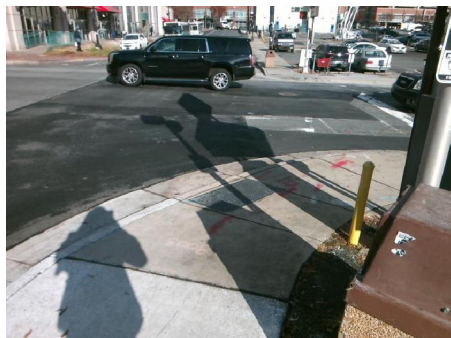
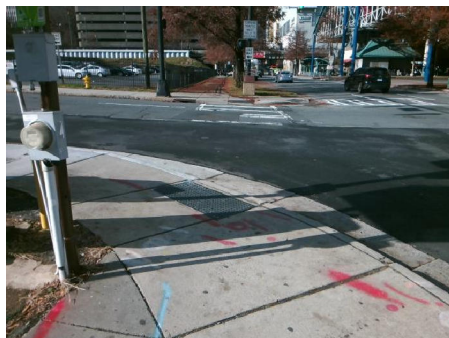
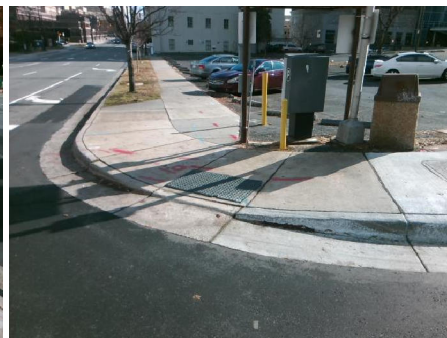
Compliance	Description	Data	Compliance	Description	Data
N/A	Ramp Length (in)	73.0	No	Ramp Slope (%)	10.9
No	Ramp Width (in)	38.0	No	Ramp XSlope (%)	10.0
N/A	Flare Type LT	N/A	N/A	Flare Type RT	N/A
N/A	Flare Slope LT (%)	N/A	N/A	Flare Slope RT (%)	N/A
N/A	Flare Traversable LT?	No	N/A	Flare Traversable RT?	No
N/A	Landing Length (in)	N/A	N/A	DWS Provided?	N/A
N/A	Landing Width (in)	N/A	N/A	DWS Contrast?	N/A
N/A	Landing Slope (%)	N/A	N/A	DWS Length (in)	N/A
N/A	Landing X Slope (%)	N/A	N/A	DWS Full Width?	N/A
N/A	Landing Curb? (Y/N)	N/A	N/A	DWS Offset (in)	N/A
N/A	Shared Landing?	N/A			
N/A	Gutter Ponding?	N/A	N/A	Gutter Slope (%)	N/A
N/A	Gutter Lip Ht (in)	N/A	N/A	Gutter X Slope (%)	N/A
N/A	Painted X Walk1?	No	N/A	Painted X Walk2?	No
	X Walk 1 Direction	To NE		X Walk 2 Direction	To NW
N/A	X Walk 1 Width (in)	N/A	N/A	X Walk 2 Width (in)	N/A
	X Walk 1 Slope (%)	0.7		X Walk 2 Slope (%)	5.8
	X Walk 1 X Slope (%)	8.4		X Walk 2 X Slope (%)	3.0

N/A	Ramp inside XWalk1?	N/A	N/A	Ramp inside XWalk2?	N/A
	Road Slope (%)	4.3	N/A	Clear Space?	N/A
	Road X Slope (%)	4.3	N/A	Clear Space to XWalk (in)	N/A
N/A	Any Obstructions?	N/A	N/A	Storm Grate/Utility Hazard?	N/A
	Obstruction Type			Storm Grate/Utility Type	
		N/A			N/A
			Yes	Surface Condition? (G/P)	Good

**Remove & Replace Curb Ramp With Two New Directional Ramps or Equivalent.**

**R304.5.1, R304.2.2, R304.5.3**
