# Access Compliance Report

## Public Rights-of-Way

### (Curb Ramps)

| Intersection ID: 48495 | Main Street: LOCH_LOMOND_DR | Cross Street: BEREWICK_COMMONS_PY | Location: W |

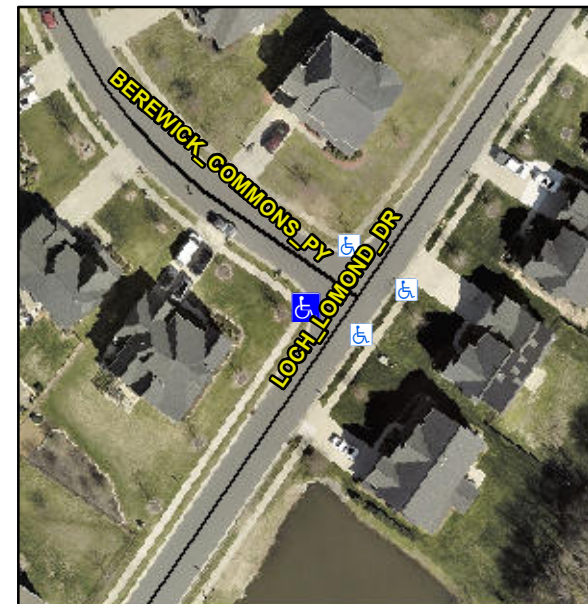
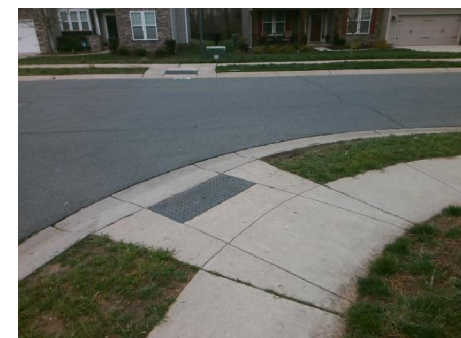
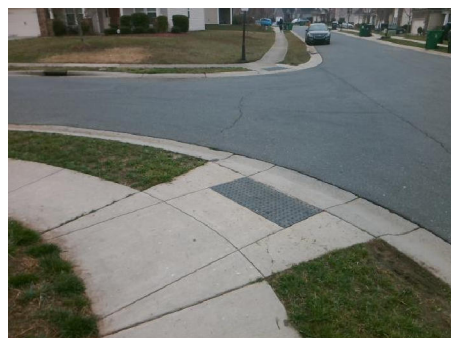
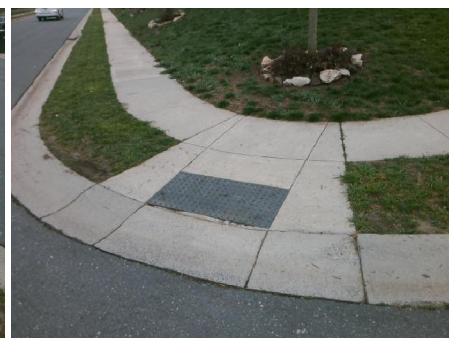
| ADA ID: 9FB462FCBBD8 | Ramp Type: PerpDiag | Initial Pass/Fail: Fail | Overall Compliance: No |
| Severity Score: 8.75 | | | |

**R304.5.1**

| Compliance | Description | Data | Compliance | Description | Data |
|---|---|---|---|---|---|
| No | Ramp Width (in) | 47.0 | Yes | Ramp XSlope (%) | 0.4 |

**Remove & Replace Curb Ramp With Two New Directional Ramps or Equivalent.**
