Access Compliance Report

Public Rights-of-Way

(Curb Ramps)

| Intersection ID: 24484 | Main Street: SAINTFIELD_PL | Cross Street: SWINFORD_PL | Location: SE |

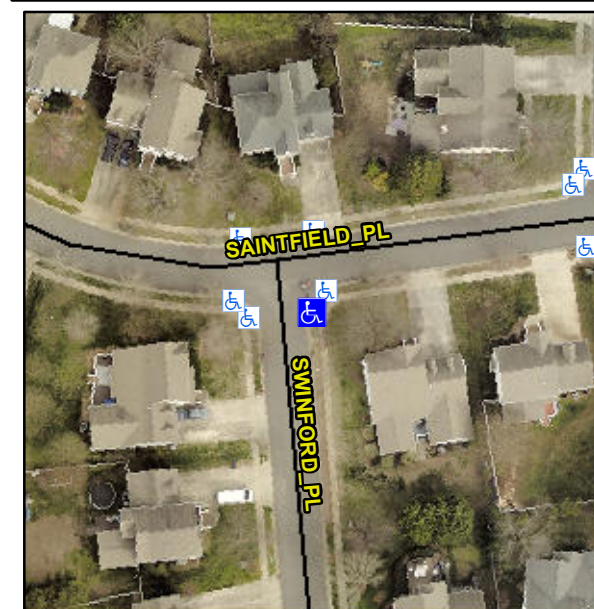
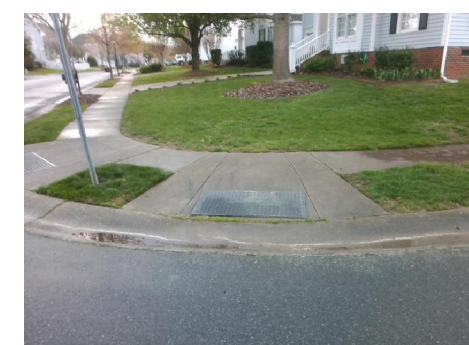
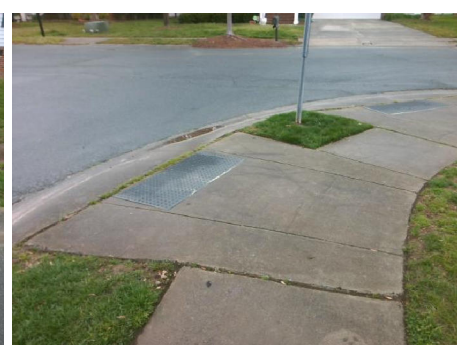
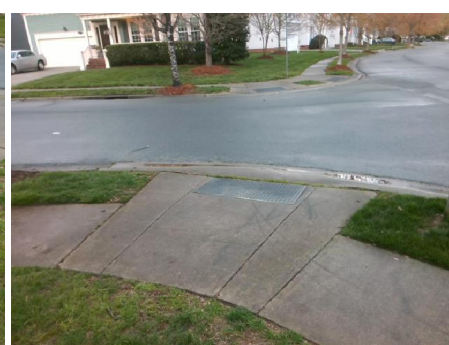
| ADA ID: 9FB5402C9AEC | Ramp Type: Perp | Initial Pass/Fail: Fail | Overall Compliance: No |
| Severity Score: 8.75 | | | |

R304.5.1

| Compliance | Description | Data | Compliance | Description | Data |
|---|---|---|---|---|---|
| No | Ramp Width (in) | 46.5 | Yes | Ramp XSlope (%) | 1.0 |

Possible Solutions:

Remove & Replace Entire Ramp.

Total Cost: \$ 1850.00
