# Access Compliance Report

## Public Rights-of-Way

### (Curb Ramps)

Intersection ID: 14474	Main Street: BROOKHILL_RD	Cross Street: S_TRYON_ST	Location: NW
ADA ID: 9FB8BCAB7958	Ramp Type: Perp	Initial Pass/Fail: Fail	Overall Compliance: No
Severity Score: 10			
Codes/Mitigation Info/Possible Solution		Field Measurements/Component Compliance

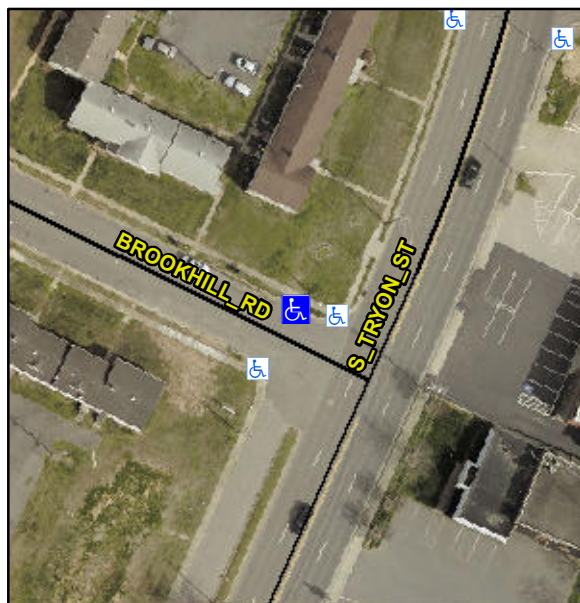
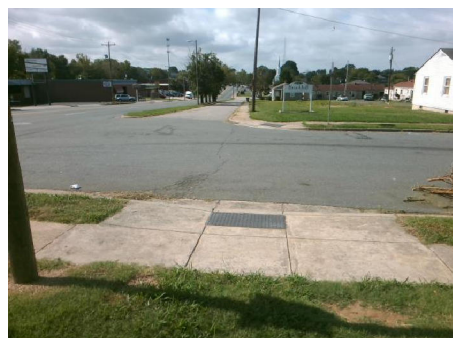
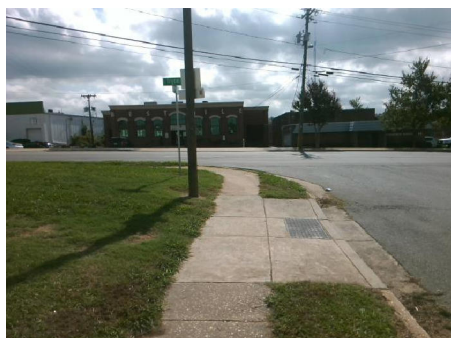
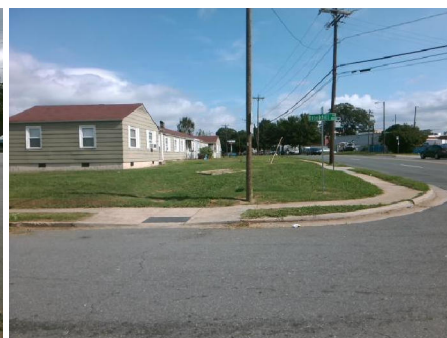
**Not Found, R304.5.1, R304.5.3**

Compliance	Description	Data	Compliance	Description	Data
N/A	Ramp Length (in)	39.0	Yes	Ramp Slope (%)	5.2
No	Ramp Width (in)	47.0	No	Ramp XSlope (%)	2.2
N/A	Flare Type LT	N/A	N/A	Flare Type RT	N/A
N/A	Flare Slope LT (%)	N/A	N/A	Flare Slope RT (%)	N/A
N/A	Flare Traversable LT?	N/A	N/A	Flare Traversable RT?	N/A
N/A	Landing Length (in)	N/A	N/A	DWS Provided?	N/A
N/A	Landing Width (in)	N/A	N/A	DWS Contrast?	N/A
N/A	Landing Slope (%)	N/A	N/A	DWS Length (in)	N/A
N/A	Landing X Slope (%)	N/A	N/A	DWS Full Width?	N/A
N/A	Landing Curb? (Y/N)	N/A	N/A	DWS Offset (in)	N/A
N/A	Shared Landing?	N/A			
N/A	Gutter Ponding?	N/A	N/A	Gutter Slope (%)	N/A
N/A	Gutter Lip Ht (in)	N/A	N/A	Gutter X Slope (%)	N/A
N/A	Painted X Walk1?	No	N/A	Painted X Walk2?	N/A
	X Walk 1 Direction	To SW		X Walk 2 Direction	N/A
N/A	X Walk 1 Width (in)	N/A	N/A	X Walk 2 Width (in)	N/A
	X Walk 1 Slope (%)	6.4		X Walk 2 Slope (%)	N/A
	X Walk 1 X Slope (%)	2.3		X Walk 2 X Slope (%)	N/A

N/A	Ramp inside XWalk1?	N/A	N/A	Ramp inside XWalk2?	N/A
	Road Slope (%)	N/A	N/A	Clear Space?	N/A
	Road X Slope (%)	N/A	N/A	Clear Space to XWalk (in)	N/A
N/A	Any Obstructions?	N/A	N/A	Storm Grate/Utility Hazard?	N/A
	Obstruction Type			Storm Grate/Utility Type	
		N/A			N/A
			Yes	Surface Condition? (G/P)	Good

**Remove & Replace Entire Ramp.**

Total Cost: \$ 1850.00
