# Access Compliance Report

## Public Rights-of-Way

### (Curb Ramps)

| Intersection ID: 30075 | Main Street: SOUTHWIND_DR | Cross Street: WOODLANDS_POINTE_DR | Location: SE |

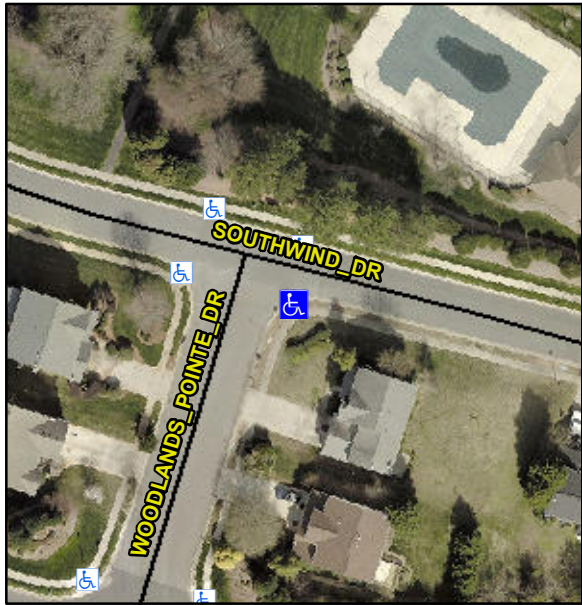
| ADA ID: 9FBEE649AC9C | Ramp Type: PerpDiag | Initial Pass/Fail: Fail | Overall Compliance: No |
| Severity Score: 26.25 | | | |

Not Found, R304.2.2, R304.5.3

| Compliance | Description | Data | Compliance | Description | Data |
|---|---|---|---|---|---|
| N/A | Ramp Length (in) | 59.0 | No | Ramp Slope (%) | 12.2 |
| Yes | Ramp Width (in) | 48.0 | No | Ramp XSlope (%) | 3.2 |

Possible Solutions:

Remove & Replace Curb Ramp With Two New Directional Ramps or Equivalent.
