Access Compliance Report

Public Rights-of-Way

(Curb Ramps)

Intersection ID: 51358	Main Street: PIKE_RD	Cross Street: BRENTMOOR_DR	Location: SE
ADA ID: 9FBF49827F86	Ramp Type: PerpDiag	Initial Pass/Fail: Pass	Overall Compliance: No
Severity Score: 0			
Codes/Mitigation Info/Possible Solution		Field Measurements/Component Compliance

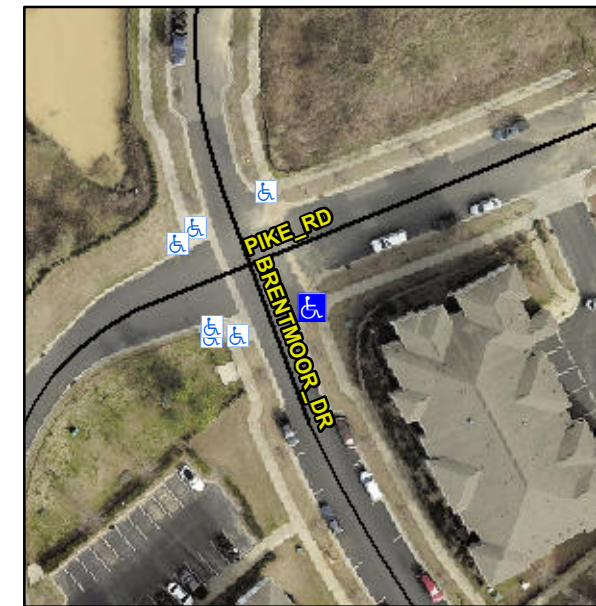
Compliance	Description	Data	Compliance	Description	Data
N/A	Ramp Length (in)	79.0	Yes	Ramp Slope (%)	6.8
Yes	Ramp Width (in)	48.0	Yes	Ramp XSlope (%)	0.7
N/A	Flare Type LT	Sloped	N/A	Flare Type RT	N/A
N/A	Flare Slope LT (%)	6.0	N/A	Flare Slope RT (%)	6.6
N/A	Flare Traversable LT?	No	N/A	Flare Traversable RT?	No
Yes	Landing Length (in)	69.0	Yes	DWS Provided?	Yes
Yes	Landing Width (in)	48.0	Yes	DWS Contrast?	Yes
Yes	Landing Slope (%)	0.8	Yes	DWS Length (in)	24.5
Yes	Landing X Slope (%)	0.9	Yes	DWS Full Width?	Yes
N/A	Landing Curb? (Y/N)	No	Yes	DWS Offset (in)	2.0
N/A	Shared Landing?	No			
Yes	Gutter Ponding?	No	Yes	Gutter Slope (%)	0.5
Yes	Gutter Lip Ht (in)	0.0	No	Gutter X Slope (%)	2.5
N/A	Painted X Walk1?	No	N/A	Painted X Walk2?	No
	X Walk 1 Direction	To N		X Walk 2 Direction	To W
N/A	X Walk 1 Width (in)	N/A	N/A	X Walk 2 Width (in)	N/A
	X Walk 1 Slope (%)	1.5		X Walk 2 Slope (%)	1.6
	X Walk 1 X Slope (%)	0.5		X Walk 2 X Slope (%)	2.2

N/A	Ramp inside XWalk1?	N/A	N/A	Ramp inside XWalk2?	N/A
	Road Slope (%)	1.7	N/A	Clear Space?	Yes
	Road X Slope (%)	0.8	N/A	Clear Space to XWalk (in)	N/A
Yes	Any Obstructions?	No	Yes	Storm Grate/Utility Hazard?	No
	Obstruction Type			Storm Grate/Utility Type	
		N/A			N/A
		Yes		Surface Condition? (G/P)	Good

Possible Solutions:

Remove & Replace Curb Slope and Extend Ramp. Remove & Replace Gutter.
