Access Compliance Report

Public Rights-of-Way

(Curb Ramps)

Intersection ID: 20140	Main Street: DEERMONT_CT	Cross Street: PINEBURR_RD	Location:	N
ADA ID: 9FC67BC35B6F	Ramp Type: BlendTrans2	Initial Pass/Fail: Fail	Overall Compliance: No	Severity Score: 25
Codes/Mitigation Info/Possible Solution		Field Measurements/Component Compliance

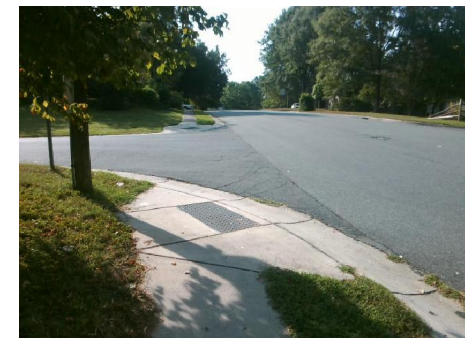
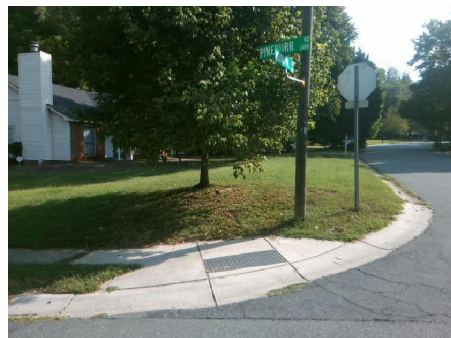
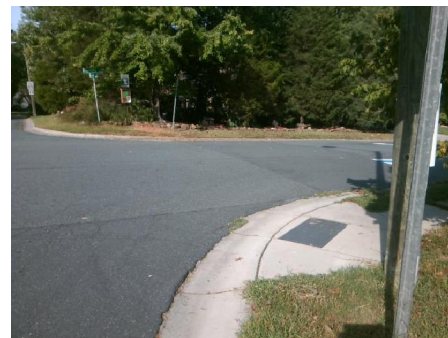
Not Found, R304.5.3

Compliance	Description	Data	Compliance	Description	Data
N/A	Ramp Length (in)	65.0	Yes	BlendTrans Slope (%)	2.0
Yes	Ramp Width (in)	48.0	No	BlendTrans XSlope (%)	8.9
N/A	Flare Type LT	N/A	N/A	Flare Type RT	N/A
N/A	Flare Slope LT (%)	N/A	N/A	Flare Slope RT (%)	N/A
N/A	Flare Traversable LT?	N/A	N/A	Flare Traversable RT?	N/A
N/A	Landing Length (in)	N/A	N/A	DWS Provided?	N/A
N/A	Landing Width (in)	N/A	N/A	DWS Contrast?	N/A
N/A	Landing Slope (%)	N/A	N/A	DWS Length (in)	N/A
N/A	Landing X Slope (%)	N/A	N/A	DWS Full Width?	N/A
N/A	Landing Curb? (Y/N)	N/A	N/A	DWS Offset (in)	N/A
N/A	Shared Landing?	N/A			
N/A	Gutter Ponding?	N/A	N/A	Gutter Slope (%)	N/A
N/A	Gutter Lip Ht (in)	N/A	N/A	Gutter X Slope (%)	N/A
N/A	Painted X Walk1?	No	N/A	Painted X Walk2?	No
	X Walk 1 Direction	To SW		X Walk 2 Direction	To SE
	X Walk 1 Width (in)	N/A		X Walk 2 Width (in)	N/A
	X Walk 1 Slope (%)	5.1		X Walk 2 Slope (%)	12.7
	X Walk 1 X Slope (%)	10.5		X Walk 2 X Slope (%)	0.5

N/A	Ramp inside XWalk1?	N/A	N/A	Ramp inside XWalk2?	N/A
	Road Slope (%)	9.0		Clear Space?	N/A
	Road X Slope (%)	6.0	N/A	Clear Space to XWalk (in)	N/A
N/A	Any Obstructions?	N/A	N/A	Storm Grate/Utility Hazard?	N/A
	Obstruction Type			Storm Grate/Utility Type	
		N/A			N/A
			Yes	Surface Condition? (G/P)	Good
			No	Curb Slope (%)	11.1

Remove & Replace Curb Ramp With Two New Directional Ramps or Equivalent.
