# Access Compliance Report

## Public Rights-of-Way

Intersection ID: 27494	Main Street: BALLANTYNE COMMONS PY	Cross Street: SUMMIT COMMONS BV	Location: SW
ADA ID: 9FD24FE1FB00	Ramp Type: Perp	Initial Pass/Fail: Fail	Overall Compliance: No
			Severity Score: 21.25

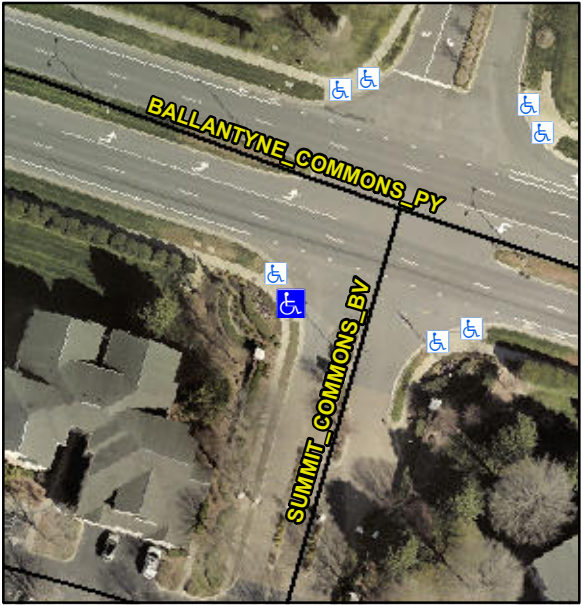
Compliance	Description	Data	Compliance	Description	Data
N/A	Ramp Length (in)	108.0	Yes	Ramp Slope (%)	5.3
No	Ramp Width (in)	43.0	No	Ramp XSlope (%)	5.8
N/A	Flare Type LT	N/A	N/A	Flare Type RT	N/A
N/A	Flare Slope LT (%)	N/A	N/A	Flare Slope RT (%)	N/A
N/A	Flare Traversable LT?	N/A	N/A	Flare Traversable RT?	N/A
N/A	Landing Length (in)	N/A	N/A	DWS Provided?	N/A
N/A	Landing Width (in)	N/A	N/A	DWS Contrast?	N/A
N/A	Landing Slope (%)	N/A	N/A	DWS Length (in)	N/A
N/A	Landing X Slope (%)	N/A	N/A	DWS Full Width?	N/A
N/A	Landing Curb? (Y/N)	N/A	N/A	DWS Offset (in)	N/A
N/A	Shared Landing?	N/A			
N/A	Gutter Ponding?	N/A	N/A	Gutter Slope (%)	N/A
N/A	Gutter Lip Ht (in)	N/A	N/A	Gutter X Slope (%)	N/A
N/A	Painted X Walk1?	No	N/A	Painted X Walk2?	N/A
	X Walk 1 Direction	To SE		X Walk 2 Direction	N/A
N/A	X Walk 1 Width (in)	N/A	N/A	X Walk 2 Width (in)	N/A
	X Walk 1 Slope (%)	3.9		X Walk 2 Slope (%)	N/A
	X Walk 1 X Slope (%)	2.7		X Walk 2 X Slope (%)	N/A

Possible Solutions:				
	Remove & Replace Entire Ramp.				
	Surveyor Notes:				
	N/A				
	PROW/ADA:				
	R304.5.1, R304.5.3				
Street 1 Name	SUMMIT COMMONS BV				
Stop Condition-Street 2	StopSign				
Street 2 Name	N/A				
Stop Condition-Street 1	N/A				
Total Cost:		\$	1850.00
