Access Compliance Report

Public Rights-of-Way

(Curb Ramps)

Intersection ID: 3415	Main Street: WHITEWOOD_TL	Cross Street: POPLAR GROVE DR	Location: SE
ADA ID: 9FE7AE27EBF3	Ramp Type: Perp	Initial Pass/Fail: Fail	Overall Compliance: No
Severity Score: 46.25			
Codes/Mitigation Info/Possible Solution		Field Measurements/Component Compliance

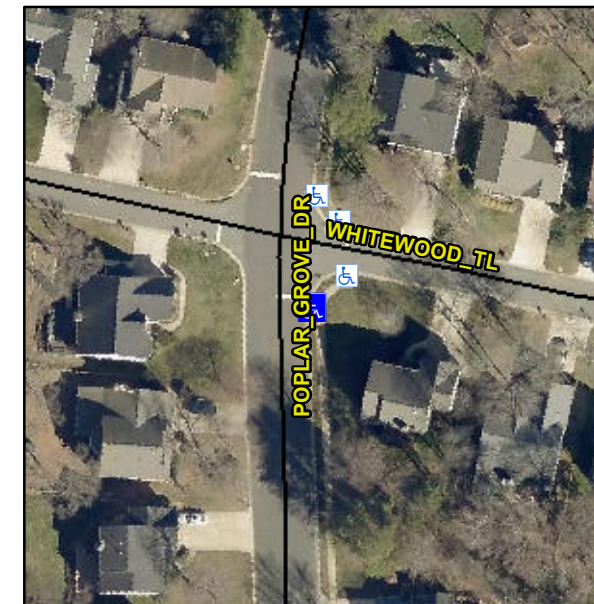
Not Found, R304.5.1, R304.2.2, R304.5.3

Compliance	Description	Data	Compliance	Description	Data
N/A	Ramp Length (in)	48.0	No	Ramp Slope (%)	9.0
No	Ramp Width (in)	46.5	No	Ramp XSlope (%)	9.9
N/A	Flare Type LT	N/A	N/A	Flare Type RT	N/A
N/A	Flare Slope LT (%)	N/A	N/A	Flare Slope RT (%)	N/A
N/A	Flare Traversable LT?	N/A	N/A	Flare Traversable RT?	N/A
N/A	Landing Length (in)	N/A	N/A	DWS Provided?	N/A
N/A	Landing Width (in)	N/A	N/A	DWS Contrast?	N/A
N/A	Landing Slope (%)	N/A	N/A	DWS Length (in)	N/A
N/A	Landing X Slope (%)	N/A	N/A	DWS Full Width?	N/A
N/A	Landing Curb? (Y/N)	N/A	N/A	DWS Offset (in)	N/A
N/A	Shared Landing?	N/A			
N/A	Gutter Ponding?	N/A	N/A	Gutter Slope (%)	N/A
N/A	Gutter Lip Ht (in)	N/A	N/A	Gutter X Slope (%)	N/A
N/A	Painted X Walk1?	No	N/A	Painted X Walk2?	N/A
	X Walk 1 Direction	To W		X Walk 2 Direction	N/A
N/A	X Walk 1 Width (in)	N/A	N/A	X Walk 2 Width (in)	N/A
	X Walk 1 Slope (%)	4.2		X Walk 2 Slope (%)	N/A
	X Walk 1 X Slope (%)	9.1		X Walk 2 X Slope (%)	N/A

Remove & Replace Entire Ramp.

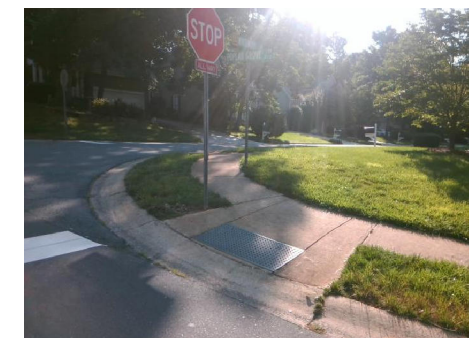
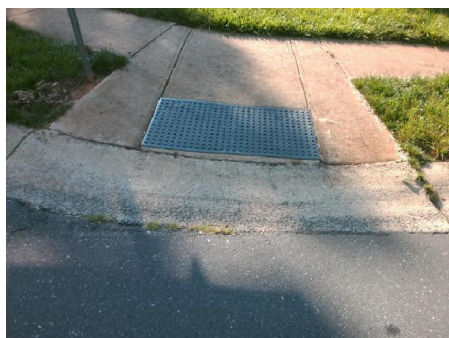
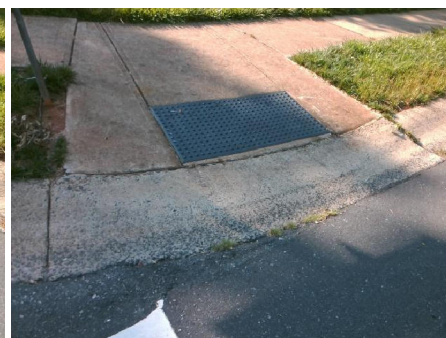
N/A	Ramp inside XWalk1?	N/A	N/A	Ramp inside XWalk2?	N/A
	Road Slope (%)	N/A	N/A	Clear Space?	N/A
	Road X Slope (%)	N/A	N/A	Clear Space to XWalk (in)	N/A
N/A	Any Obstructions?	N/A	N/A	Storm Grate/Utility Hazard?	N/A
	Obstruction Type			Storm Grate/Utility Type	
		N/A			N/A
			Yes	Surface Condition? (G/P)	Good
