Access Compliance Report

Public Rights-of-Way

(Curb Ramps)

Intersection ID: 10022154	Main Street: BURNETTE_AV	Cross Street: N/A	Location: SE
ADA ID: 9FEEA24E98DD	Ramp Type: Directional1	Initial Pass/Fail: Fail	Overall Compliance: No
			Severity Score: 13.75

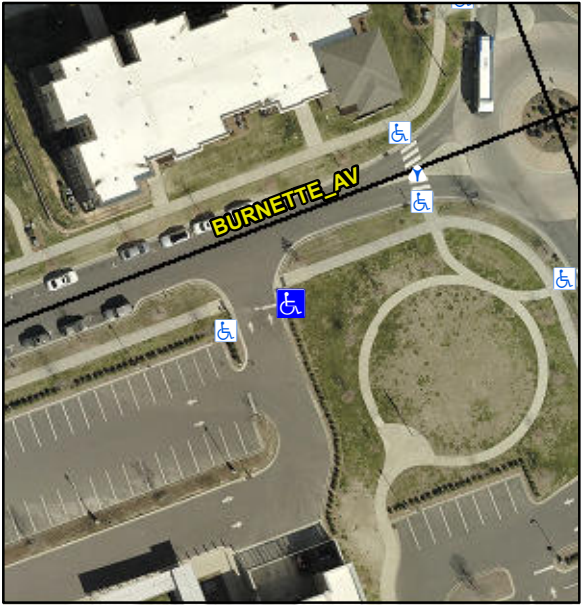
Possible Solutions:	Remove & Replace Entire Ramp.					
	Surveyor Notes:	N/A					
	PROW/ADA:	R304.2.2, R304.5.3					
	Street 1 Name	ENTRANCE					
	Stop Condition-Street 1	StopSign					
	Street 2 Name	N/A					
	Stop Condition-Street 2	N/A					
			Compliance	Description	Data	Compliance	Description
			N/A	Ramp Length (in)	175.0	N/A	Grade Break?
			Yes	Ramp Width (in)	72.0	N/A	Grade Break Slope (%)
			No	Ramp Slope (%)	10.5	N/A	Grade Break XSlope (%)
			No	Ramp XSlope (%)	2.6		
			N/A	Flare Type LT	N/A	N/A	Flare Type RT
			N/A	Flare Slope LT (%)	N/A	N/A	Flare Slope RT (%)
			N/A	Flare Traversable LT?	N/A	N/A	Flare Traversable RT?
			N/A	Landing Length (in)	0.0	N/A	DWS Provided?
			N/A	Landing Width (in)	0.0	N/A	DWS Contrast?
			N/A	Landing Slope (%)	0.0	N/A	DWS Length (in)
			N/A	Landing X Slope (%)	0.0	N/A	DWS Full Width?
			N/A	Landing Curb? (Y/N)	N/A	N/A	DWS Offset LT (in)

N/A	Shared Landing?	N/A	N/A	DWS Offset RT (in)
			N/A	Gutter Ponding?	0.0	N/A	Gutter Slope (%)
			N/A	Gutter Lip Ht (in)	0.0	N/A	Gutter X Slope (%)
			N/A	Painted X Walk1?	No		Road Slope (%)
				X Walk 1 Direction	To SW		Road X Slope (%)
				X Walk 1 Width (in)	N/A		Clear Space?
				X Walk 1 Slope (%)	6.6	N/A	Clear Space to XWalk (in)
				X Walk 1 X Slope (%)	2.7	N/A	Storm Grate/Utility Hazard?
			N/A	Ramp inside XWalk1?	N/A		Storm Grate/Utility Type
			N/A	Any Obstructions?	N/A		
				Obstruction Type		Yes	Surface Condition? (G/P)
						N/A	Curb Slope (%)
Total Cost:		\$ 1600.00
