# Access Compliance Report

## Public Rights-of-Way

### (Curb Ramps)

Intersection ID: 26468	Main Street: BEVINGTON_PL	Cross Street: REA_RD	Location: NW
ADA ID: 9FEF886EABDC	Ramp Type: Perp	Initial Pass/Fail: Fail	Overall Compliance: No
Severity Score: 33.75			
Codes/Mitigation Info/Possible Solution		Field Measurements/Component Compliance

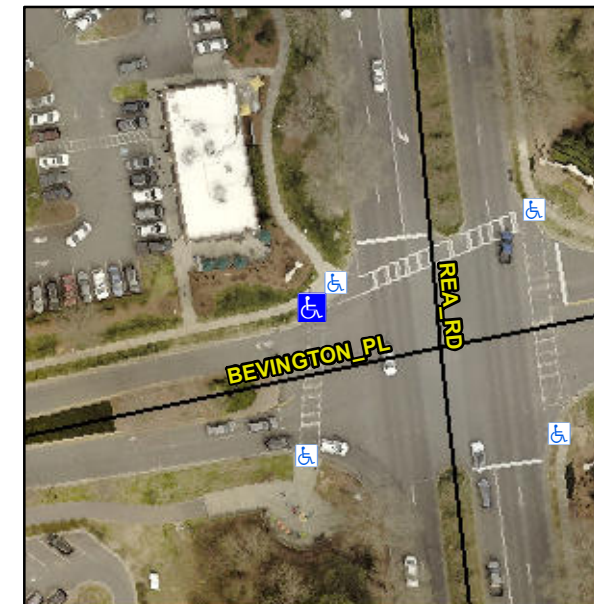
**Not Found, R304.5.1, R304.2.2, R304.5.3**

Compliance	Description	Data	Compliance	Description	Data
N/A	Ramp Length (in)	71.0	No	Ramp Slope (%)	8.4
No	Ramp Width (in)	47.0	No	Ramp XSlope (%)	5.8
N/A	Flare Type LT	N/A	N/A	Flare Type RT	N/A
N/A	Flare Slope LT (%)	N/A	N/A	Flare Slope RT (%)	N/A
N/A	Flare Traversable LT?	N/A	N/A	Flare Traversable RT?	N/A
N/A	Landing Length (in)	N/A	N/A	DWS Provided?	N/A
N/A	Landing Width (in)	N/A	N/A	DWS Contrast?	N/A
N/A	Landing Slope (%)	N/A	N/A	DWS Length (in)	N/A
N/A	Landing X Slope (%)	N/A	N/A	DWS Full Width?	N/A
N/A	Landing Curb? (Y/N)	N/A	N/A	DWS Offset (in)	N/A
N/A	Shared Landing?	N/A			
N/A	Gutter Ponding?	N/A	N/A	Gutter Slope (%)	N/A
N/A	Gutter Lip Ht (in)	N/A	N/A	Gutter X Slope (%)	N/A
N/A	Painted X Walk1?	Yes	N/A	Painted X Walk2?	N/A
	X Walk 1 Direction	To SW		X Walk 2 Direction	N/A
N/A	X Walk 1 Width (in)	105.0	N/A	X Walk 2 Width (in)	N/A
	X Walk 1 Slope (%)	3.2		X Walk 2 Slope (%)	N/A
	X Walk 1 X Slope (%)	4.2		X Walk 2 X Slope (%)	N/A

N/A	Ramp inside XWalk1?	Yes	N/A	Ramp inside XWalk2?	N/A
	Road Slope (%)	N/A	N/A	Clear Space?	N/A
	Road X Slope (%)	N/A	N/A	Clear Space to XWalk (in)	N/A
N/A	Any Obstructions?	N/A	N/A	Storm Grate/Utility Hazard?	N/A
	Obstruction Type			Storm Grate/Utility Type	
		N/A			N/A
			Yes	Surface Condition? (G/P)	Good

Possible Solutions:

**Remove & Replace Entire Ramp.**
