Access Compliance Report

Public Rights-of-Way

(Curb Ramps)

Intersection ID: N/A	Main Street: PERIWINKLE_HILL_CT	Cross Street: N/A	Location: N
ADA ID: 9FF505D62592	Ramp Type: Perp	Initial Pass/Fail: Fail	Overall Compliance: No
Severity Score: 12.5			
Codes/Mitigation Info/Possible Solution		Field Measurements/Component Compliance

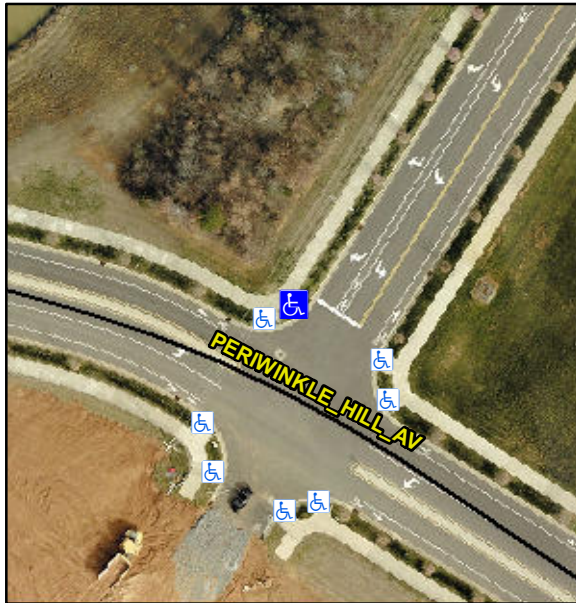
Compliance	Description	Data	Compliance	Description	Data
N/A	Ramp Length (in)	94.0	No	Ramp Slope (%)	10.7
Yes	Ramp Width (in)	94.0	Yes	Ramp XSlope (%)	1.6
N/A	Flare Type LT	N/A	N/A	Flare Type RT	N/A
N/A	Flare Slope LT (%)	N/A	N/A	Flare Slope RT (%)	N/A
N/A	Flare Traversable LT?	N/A	N/A	Flare Traversable RT?	N/A
N/A	Landing Length (in)	N/A	N/A	DWS Provided?	N/A
N/A	Landing Width (in)	N/A	N/A	DWS Contrast?	N/A
N/A	Landing Slope (%)	N/A	N/A	DWS Length (in)	N/A
N/A	Landing X Slope (%)	N/A	N/A	DWS Full Width?	N/A
N/A	Landing Curb? (Y/N)	N/A	N/A	DWS Offset (in)	N/A
N/A	Shared Landing?	N/A			
N/A	Gutter Ponding?	N/A	N/A	Gutter Slope (%)	N/A
N/A	Gutter Lip Ht (in)	N/A	N/A	Gutter X Slope (%)	N/A
N/A	Painted X Walk1?	No	N/A	Painted X Walk2?	N/A
	X Walk 1 Direction	To SE		X Walk 2 Direction	N/A
N/A	X Walk 1 Width (in)	N/A	N/A	X Walk 2 Width (in)	N/A
	X Walk 1 Slope (%)	4.9		X Walk 2 Slope (%)	N/A
	X Walk 1 X Slope (%)	0.7		X Walk 2 X Slope (%)	N/A

N/A	Ramp inside XWalk1?	N/A	N/A	Ramp inside XWalk2?	N/A
	Road Slope (%)	N/A	N/A	Clear Space?	N/A
	Road X Slope (%)	N/A	N/A	Clear Space to XWalk (in)	N/A
N/A	Any Obstructions?	N/A	N/A	Storm Grate/Utility Hazard?	N/A
	Obstruction Type			Storm Grate/Utility Type	
		N/A			N/A
		Yes		Surface Condition? (G/P)	Good

Possible Solutions:

Remove & Replace Entire Ramp.

PROW/ADA:

R304.2.2
