# Access Compliance Report

## Public Rights-of-Way

### (Curb Ramps)

Intersection ID: 5462	Main Street: CARVER_BV	Cross Street: CARVER_PL	Location: W
ADA ID: A0193C26C95E	Ramp Type: Para	Initial Pass/Fail: Fail	Overall Compliance: No
			Severity Score: 30

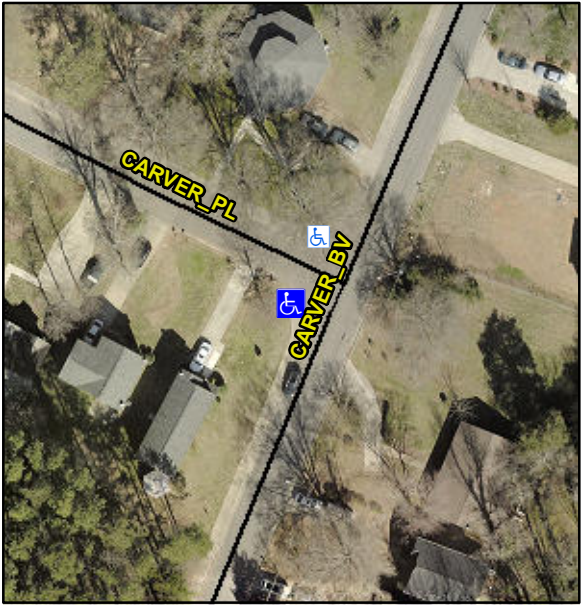
Possible Solutions:		<b>Compliance</b>	<b>Description</b>	<b>Data</b>
	<b>Remove &amp; Replace Entire Ramp.</b>		<b>N/A</b>	Ramp Length LT (in)	<b>66.0</b>
			<b>No</b>	Ramp Width LT (in)	<b>35.0</b>
			<b>Yes</b>	Ramp Slope LT (%)	<b>6.0</b>
			<b>Yes</b>	Ramp XSlope LT (%)	<b>1.1</b>
			<b>N/A</b>	Landing Length (in)	<b>N/A</b>
			<b>N/A</b>	Landing Width (in)	<b>N/A</b>
			<b>N/A</b>	Landing Slope (%)	<b>N/A</b>
			<b>N/A</b>	Landing X Slope (%)	<b>N/A</b>
			<b>N/A</b>	Landing Curb? (Y/N)	<b>N/A</b>
<p>Surveyor Notes:</p> <p><b>N/A</b></p> <p>PROW/ADA:</p> <p><b>R304.5.1, R304.3.2</b></p>			<b>N/A</b>	Ramp XSlope RT (%)	<b>1.2</b>
			<b>N/A</b>	DWS Provided?	<b>N/A</b>
			<b>N/A</b>	DWS Contrast?	<b>N/A</b>
			<b>N/A</b>	DWS Length (in)	<b>N/A</b>
			<b>N/A</b>	DWS Full Width?	<b>N/A</b>
			<b>N/A</b>	DWS Offset (in)	<b>N/A</b>

<b>N/A</b>	Gutter Slope (%)	<b>N/A</b>
			<b>N/A</b>	Gutter X Slope (%)	<b>N/A</b>
			<b>N/A</b>	Painted X Walk1?	<b>No</b>
			<b>N/A</b>	X Walk 1 Direction	<b>To NE</b>
			<b>N/A</b>	X Walk 1 Width (in)	<b>N/A</b>
				X Walk 1 Slope (%)	<b>4.6</b>
				X Walk 1 X Slope (%)	<b>1.9</b>
			<b>N/A</b>	Ramp inside XWalk1?	<b>N/A</b>
				Road Slope (%)	<b>N/A</b>
				Road X Slope (%)	<b>N/A</b>
			<b>N/A</b>	Any Obstructions?	<b>N/A</b>
				Obstruction Type	
			<b>N/A</b>	Storm Grate/Utility Hazard?	<b>N/A</b>
				Storm Grate/Utility Type	
Total Cost:		<b>\$ 1600.00</b>	<b>N/A</b>		<b>N/A</b>
			<b>Yes</b>	Surface Condition? (G/P)	<b>Good</b>
			<b>N/A</b>	Curb Slope (%)	<b>19.3</b>
