Intersection ID: 11754	Main Street: MECKLENBURG_AV	Cross Street: THURMOND_PL	Location:	SW
ADA ID: A02208712434	Ramp Type: PerpDiag	Initial Pass/Fail: Fail	Overall Compliance: No	Severity Score: 33.75

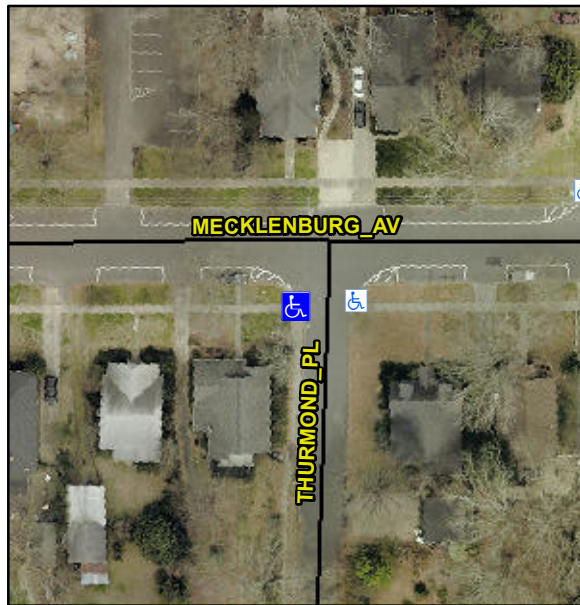
Not Found, R304.5.1, R304.2.2

Compliance	Description	Data	Compliance	Description	Data
N/A	Ramp Length (in)	62.0	No	Ramp Slope (%)	13.3
No	Ramp Width (in)	47.5	Yes	Ramp XSlope (%)	1.8
N/A	Flare Type LT	N/A	N/A	Flare Type RT	N/A
N/A	Flare Slope LT (%)	N/A	N/A	Flare Slope RT (%)	N/A
N/A	Flare Traversable LT?	N/A	N/A	Flare Traversable RT?	N/A
N/A	Landing Length (in)	N/A	N/A	DWS Provided?	N/A
N/A	Landing Width (in)	N/A	N/A	DWS Contrast?	N/A
N/A	Landing Slope (%)	N/A	N/A	DWS Length (in)	N/A
N/A	Landing X Slope (%)	N/A	N/A	DWS Full Width?	N/A
N/A	Landing Curb? (Y/N)	N/A	N/A	DWS Offset (in)	N/A
N/A	Shared Landing?	N/A			
N/A	Gutter Ponding?	N/A	N/A	Gutter Slope (%)	N/A
N/A	Gutter Lip Ht (in)	N/A	N/A	Gutter X Slope (%)	N/A
N/A	Painted X Walk1?	No	N/A	Painted X Walk2?	No
	X Walk 1 Direction	To E		X Walk 2 Direction	To N
N/A	X Walk 1 Width (in)	N/A	N/A	X Walk 2 Width (in)	N/A
	X Walk 1 Slope (%)	3.0		X Walk 2 Slope (%)	2.8
	X Walk 1 X Slope (%)	4.0		X Walk 2 X Slope (%)	3.1

N/A	Ramp inside XWalk1?	N/A	N/A	Ramp inside XWalk2?	N/A
	Road Slope (%)	2.2	N/A	Clear Space?	N/A
	Road X Slope (%)	3.5	N/A	Clear Space to XWalk (in)	N/A
N/A	Any Obstructions?	N/A	N/A	Storm Grate/Utility Hazard?	N/A
	Obstruction Type			Storm Grate/Utility Type	
		N/A			N/A
			Yes	Surface Condition? (G/P)	Good

Possible Solutions:

Remove & Replace Curb Ramp With Two New Directional Ramps or Equivalent.
