Access Compliance Report

Public Rights-of-Way (Curb Ramps)

Intersection ID: 14281	Main Street: E_KINGSTON_AV	Cross Street: LYNDHURST_AV	Location: E
ADA ID: A033EB15F313	Ramp Type: Directional1	Initial Pass/Fail: Fail	Overall Compliance: No
		Severity Score: 1.25

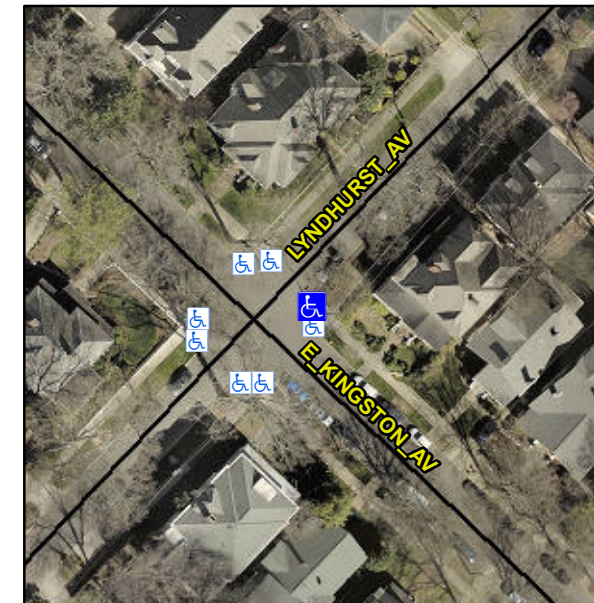
Compliance	Description	Data	Compliance	Description	Data
N/A	Ramp Length (in)	89.0	N/A	Grade Break?	N/A
Yes	Ramp Width (in)	48.0	N/A	Grade Break Slope (%)	0.0
Yes	Ramp Slope (%)	7.3	N/A	Grade Break XSlope (%)	0.0
No	Ramp XSlope (%)	3.9			
N/A	Flare Type LT	N/A	N/A	Flare Type RT	N/A
N/A	Flare Slope LT (%)	N/A	N/A	Flare Slope RT (%)	0.0
N/A	Flare Traversable LT?	N/A	N/A	Flare Traversable RT?	N/A
N/A	Landing Length (in)	0.0	N/A	DWS Provided?	N/A
N/A	Landing Width (in)	0.0	N/A	DWS Contrast?	N/A
N/A	Landing Slope (%)	0.0	N/A	DWS Length (in)	N/A
N/A	Landing X Slope (%)	0.0	N/A	DWS Full Width?	N/A
N/A	Landing Curb? (Y/N)	N/A	N/A	DWS Offset LT (in)	N/A
N/A	Shared Landing?	N/A	N/A	DWS Offset RT (in)	N/A
N/A	Gutter Ponding?	0.0	N/A	Gutter Slope (%)	N/A
N/A	Gutter Lip Ht (in)	1.0	N/A	Gutter X Slope (%)	N/A
N/A	Painted X Walk1?	No		Road Slope (%)	4.5
	X Walk 1 Direction	To NW		Road X Slope (%)	2.5
	X Walk 1 Width (in)	N/A		Clear Space?	N/A

X Walk 1 Slope (%)	4.5	N/A	Clear Space to XWalk (in)	N/A
	X Walk 1 X Slope (%)	2.5	N/A	Storm Grate/Utility Hazard?	N/A
N/A	Ramp inside XWalk1?	N/A		Storm Grate/Utility Type	
N/A	Any Obstructions?	N/A			N/A
	Obstruction Type		Yes	Surface Condition? (G/P)	Good
			N/A	Curb Slope (%)	1.1

Possible Solutions:

Remove & Replace Entire Ramp.

PROW/ADA:

R304.5.3
