# Access Compliance Report

## Public Rights-of-Way

### (Curb Ramps)

| Intersection ID: 27197 | Main Street: BALLANTYNE COMMONS PY | Cross Street: CRESTWOOD DR | Location: NW |

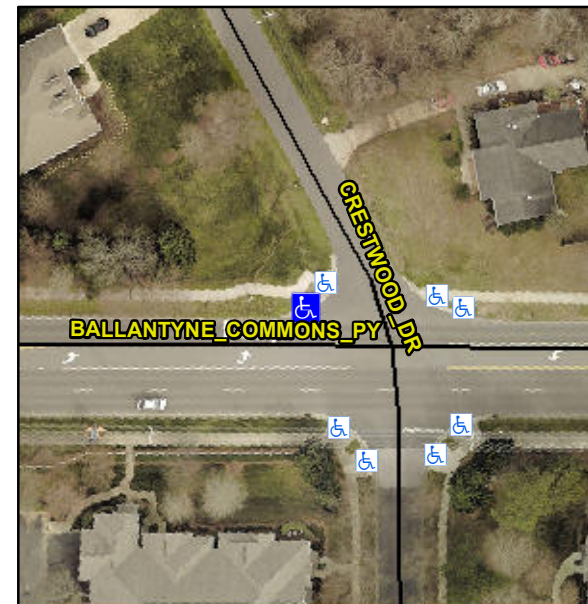
| Compliance | Description | Data | Compliance | Description | Data |
|---|---|---|---|---|---|
| N/A | Ramp Length (in) | 90.0 | No | Ramp Slope (%) | 10.9 |
| No | Ramp Width (in) | 47.0 | No | Ramp XSlope (%) | 3.6 |

**Remove & Replace Entire Ramp.**
