| Intersection ID: 28253 | Main Street: EASTON_GREY_LN | Cross Street: PEMSWOOD_ST | Location: | SE |
| ADA ID: A0386A56B301 | Ramp Type: PerpDiag | Initial Pass/Fail: Fail | Overall Compliance: No | Severity Score: 13.75 |

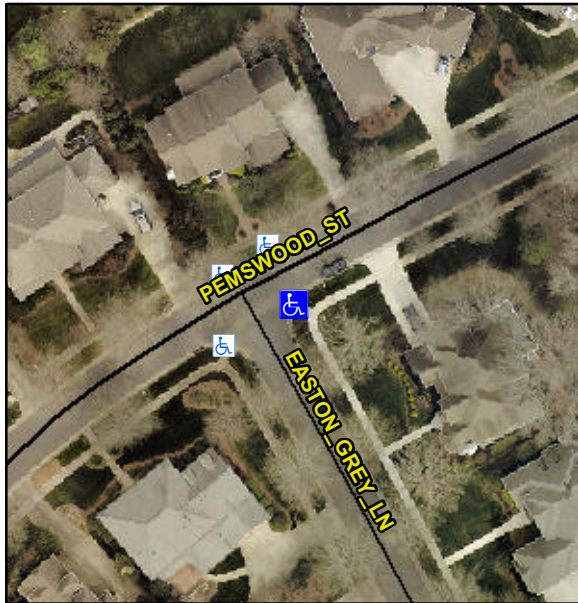
**R304.2.2, R304.5.3**

| Compliance | Description | Data | Compliance | Description | Data |
|---|---|---|---|---|---|
| N/A | Ramp Length (in) | 100.0 | No | Ramp Slope (%) | 11.5 |
| Yes | Ramp Width (in) | 54.0 | No | Ramp XSlope (%) | 2.2 |

**Remove & Replace Curb Ramp With Two New Directional Ramps or Equivalent.**

Total Cost: \$ 3200.00
