# Access Compliance Report

## Public Rights-of-Way

### (Curb Ramps)

| Intersection ID: N/A | Main Street: COYLE CIR | Cross Street: N/A | Location: SW |

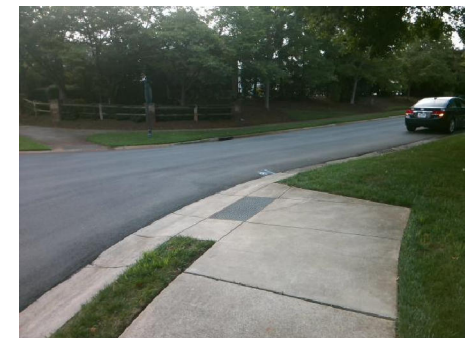
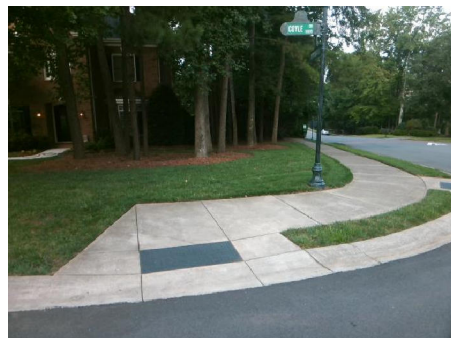
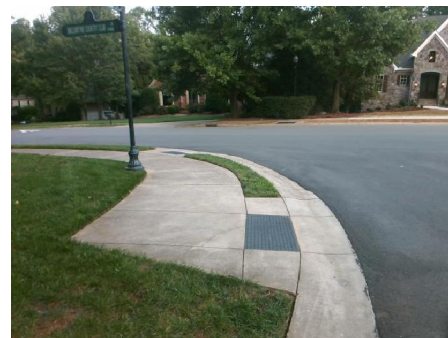
| ADA ID: A03D0E60992E | Ramp Type: BlendTrans2 | Initial Pass/Fail: Fail | Overall Compliance: No |
| | | Severity Score: 10 | |

| Compliance | Description | Data | Compliance | Description | Data |
|---|---|---|---|---|---|
| No | Ramp Width (in) | 47.5 | No | BlendTrans XSlope (%) | 2.5 |

**Remove & Replace Curb Ramp With Two New Directional Ramps or Equivalent.**

**R304.5.1, R304.5.3**
